GB and TC Input Shaft Inspection

This product alert applies to all Canrig Commander™ Drawworks 2000, serial numbers 1 – 73.

RIGLINE 24/7™ Support Line: 866.433.4345 | International: +1 281.774.5649 | E-mail: support@rigline247.com Document ID 17-009 v 1.0 | Copyright © 2017 Canrig Drilling Technology Ltd. All rights reserved

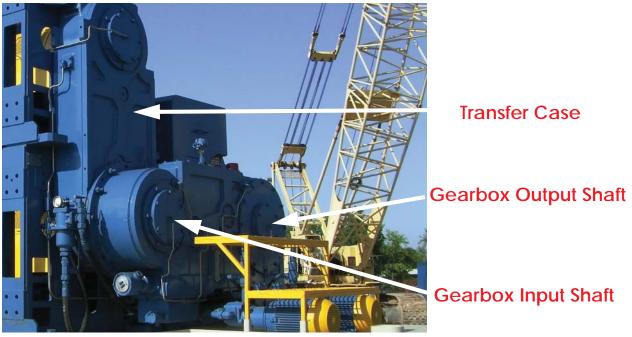
Figure 1: Gearbox and Transfer Case location on Drawworks 2000

The current brake system configuration lacks brake modulation to avoid high load shock during brake set. If brakes are applied too fast, gearbox gears and snap rings can become damaged.

The gearbox input shaft may move axially approximately $\frac{1}{2}$ – $\frac{3}{4}$ inch, shearing off or popping out the retaining rings and causing the transfer case output gear to make contact with the transfer case. In other instances, the transfer case input shaft assembly may move axially approximately $\frac{1}{2}$ inch, shearing off or popping out the retaining rings.

Inspect gearbox (GB) and transfer case (TC) snap ring for damage or dislocation. Contact RIGLINE 24/7™ Support if problem found.

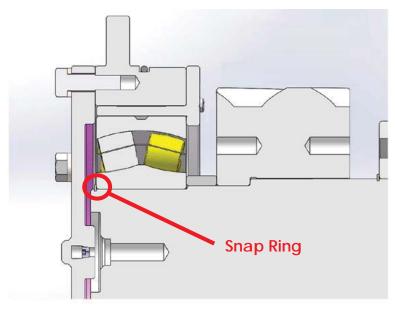
Figure 5: GB Output Shaft Schematic with Seal Detail. Snap Ring indicated.

- 1. Remove lube lines.
- 2. Open GB output shaft cover.
- 3. Check snap ring. If snap ring is damaged or popped out from groove, stop using drawworks and contact RIGLINE 24/7[™] Support immediately.
- 4. Reinstall cover plate and lube line. Ensure that there are no oil leaks.
