Model: 350, 500, and 750 Ton

Top Drive

Product Bulletin # TDS-141

Upper Link Modification

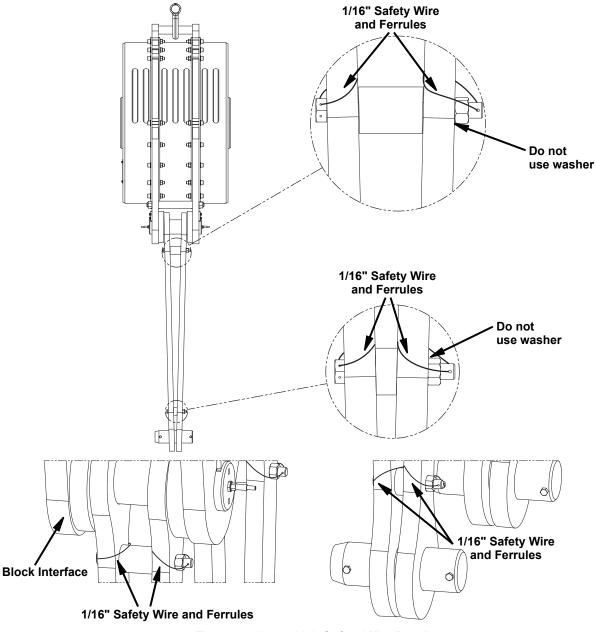
Figure 2: Upper Link Safety Wire Detail

The bolts used to retain the upper link spacers need secondary retention. This is required to maintain integrity of the connection between the bolt, spacer, and nut in the event of a failure. For example, shearing of the bolt.

- 4. Install safety wire and ferrules on bolts as follows: (See Figure 2)
 - a. Remove washers. Washers are not required for this assembly.
 - b. Torque lock nuts to 400 ft-lbs (360-462 ft-lbs).
 - c. Secure a loop of safety wire through the bolt head and around adjacent upper link and another loop of safety wire through the bolt end and around adjacent upper link. Ensure excess slack is removed.
