Top Drive Frame Base Inspection

RIGLINE 24/7™ Support: 866.433.4345 | International: +1 281.774.5649 | E-mail: <u>support@rigline247.com</u> Document ID 17-059 v 1.0 | Copyright © 2017 Canrig Drilling Technology Ltd. All rights reserved.

Top Drive Frame Weld Repair Procedure

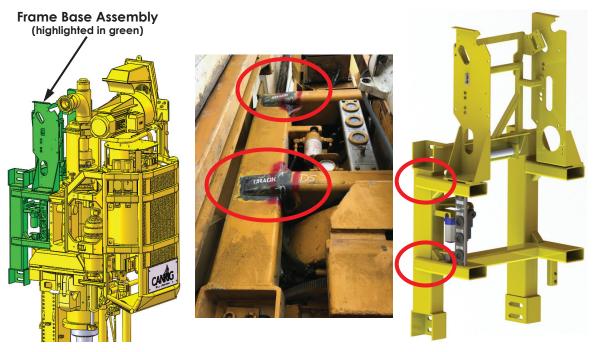
A crack may form on the top drive frame as a result of rough drilling or fatigue.

Figure 1: Frame Base Inspection Areas. Inspect both sides.

- Inspect the top drive frame for any visible sign of cracks. Canrig recommends a regular inspection of the top drive to identify cracks and other signs of damage and wear. See section 4B of the Canrig top drive manual. Paint flaking or cracking can be an indicator of cracks in the weld or base metal beneath.
- Inspect the top drive frame after any impact events and after periods of rough drilling or jarring. Refer to section 4B of the Canrig Top Drive manual for additional inspection recommendations following rough drilling and jarring.
- If any visible signs of cracks are found, repair the cracks at the earliest opportunity following the procedure below.
