Model: EXI800 Top Drives
Serial #: See affected units

Product Bulletin # TDS-201

Oil Cooler Mounting Bracket

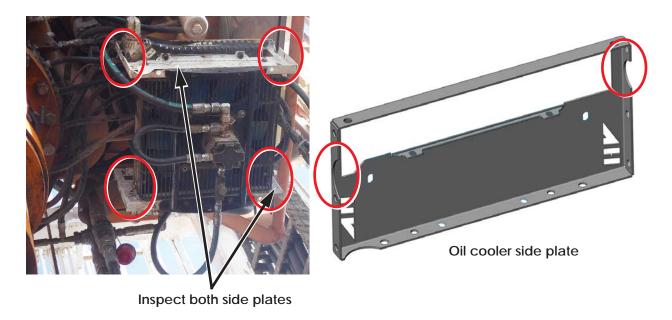
Figure 1: Oil Cooler Mounting Bracket Inspection Locations

Canrig advises all operators of EXI800 older model top drives (with a mechanical driven lubrication pump) to perform an immediate visual inspection of the oil cooler mounting bracket. Look for cracks or damage, in particular the mounting plates on the sides of the cooler as indicated in Figure 1 below.

If a side plate is cracked or broken, **stop operations immediately** and contact RIGLINE 24/7TM Support for a remedial action plan. If no cracks or broken side plates are found, proceed with operations and continue the daily inspection requirement as per the corresponding top drive maintenance manual.
