Model: 500/650/750 Ton TDs

Product Bulletin # TDS-213 v 1.0

Top Drive Limit Switch Guard

Product Bulletin # TDS-150

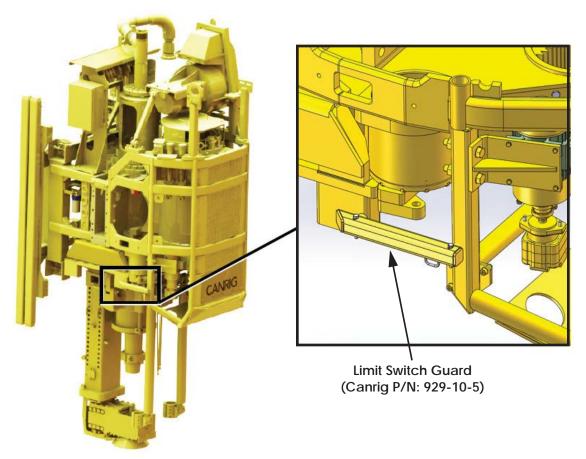
Figure 1: Limit switch guard location

Incorrect installation of the top drive limit switch guard (Canrig P/N: 929-10-5) creates a risk that a winch cable will snag (see Figure 2 on page 2) on the limit switch guard while using hoisting lines.

- 1. Visually inspect the limit switch guard on top drive to identify which limit switch guard is installed. Verify the fasteners are properly torqued and safety securement is installed.
- 2. No further action is required if:
 - 2a. Limit switch guard Canrig P/N: DT22459 is correctly installed (refer to Figure 3 on page 2).
 - 2b. Limit switch guard Canrig P/N: 929-10-5 is installed and was modified per Canrig Product Alert TDS-150 (released on July 28, 2015).
 - 2c. Limit switch guard was correctly replaced with modified design Canrig P/N: DT22650 (refer to Figure 4 above).

3. If the unmodified limit switch guard Canrig P/N: 929-10-5 is installed (refer to Figure 1 on page 1 and Figure 2 on page 2), modify the limit switch guard per following instruction.

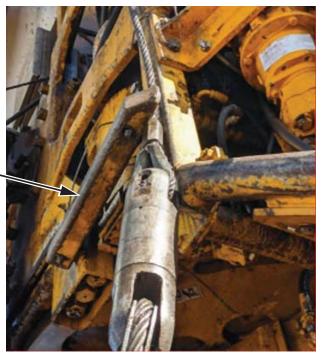
Figure 2: Winch line stuck in limit switch guard (Canrig P/N: 929-10-5)

Limit Switch Guard (Canrig P/N: 929-10-5). was installed incorrectly

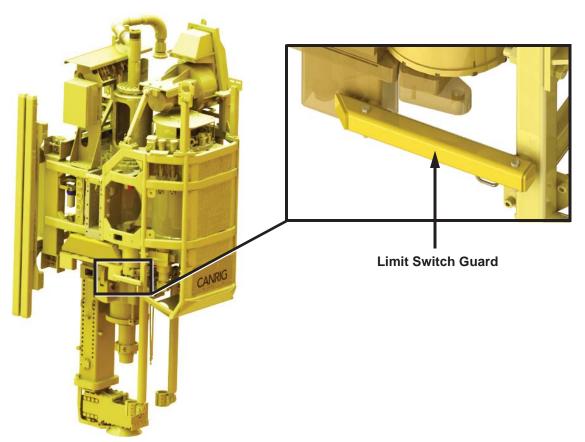
Figure 1: Top Drive Limit Switch Guard Location

Care should always be taken when using lifting or winch cables around the top drive. There should always be someone monitoring the top drive to ensure nothing gets hooked or snagged. There are two gaps between the limit switch guard and the main guard assembly, located on the 500/650/750 ton top drive guard assemblies. Without proper monitoring, cables could inadvertently get in-between the components and potentially dislodge the limit switch guard and cause it to fall.
