# TORQ-MATIC WRENCH PRODUCT BULLETINS

**CANRIG PRODUCT BULLETIN MANUAL**

Product Bulletin #	Subject	Page
Wrench 001	Leaking Fittings within the hydraulic valve Banks	5
Wrench 002	Cylinder Gusset Failure on Main Boom	6
Wrench 003	Orientation of spinner roller seals	7
Wrench 004	Shearing Belleville Stack Mounting Studs	10
Wrench 005	Inspection of Main Boom Pin Tube and Support Gussets	15
Wrench 006	High Pressure Control Seats for Hydraulic Valve	24
Wrench 007	Inspection of Vertical Lift Channel	27
Wrench 008	Tong Cylinder Orifice	27
Wrench 009	37-Pin Cable and Receptacle Cap Plugs Getting Pinched	30
Wrench 010	Cable Guide / Encoder Guard	33
Wrench 011	Locking Joystick on Driller's Console	37
Wrench 012	Sealed Electric Operator for Horizontal Extend/Retract Valve	42
Wrench 013	Tong Cyliner Upgrade	56
Wrench 014	Wrench Lifting Procedure	61

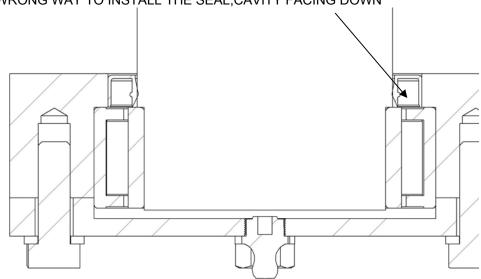
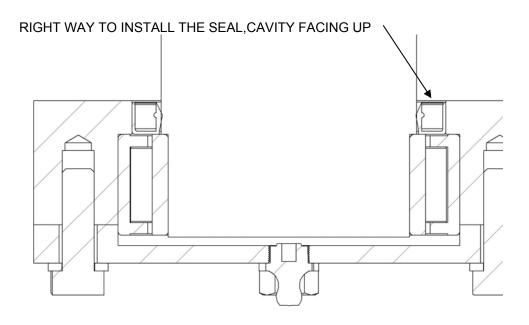
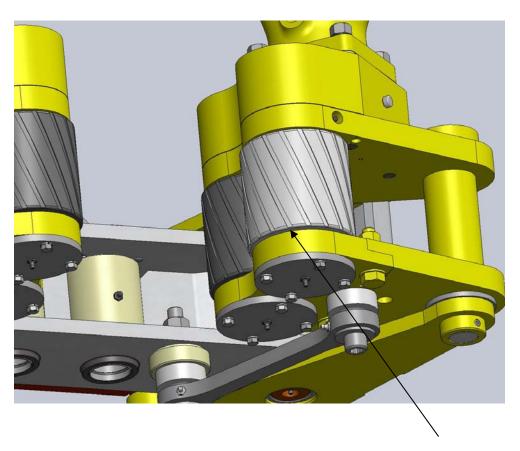
**DISCUSSION:** CANRIG has discovered that early production units of the TM-80 may have had

the grease seals installed upside down. This prevent excess grease and pressure

from exiting the cavity and may eject the seal or push the roller shaft up.

GREASE SHOULD BE VISIBLE UNDER ROLLER

Check seal orientation by greasing spinner roller shafts, grease should come out under rollers. If not the seal is installed upside down, unscrew grease nipple to release excess pressure.

Contact CANRIG to ship 4 of seal P/N S10104 and 4 of bearing P/N M10644 See DWG # 188200005 for installation instructions.

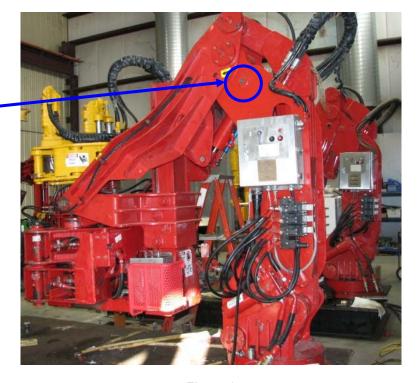
Figure 1

reach) wrench, discovered cracks along the welds connecting support gussets to the horizontal cylinder pin tubes located near the top of the main boom. Both

Examination of the weld joints revealed voids between the support gussets and pin tubes, poor penetration of the weld into the gusset material, and lack of weld fusion with the pin tubes. Canrig estimates that the inferior quality of the welds could have reduced the maximum allowable stress in that area by as much as 70%. Because the weld deficiencies were hidden underneath the weld, they

Canrig is currently working with the manufacturer to identify and repair other booms in stock which could exhibit the same deficiencies. In addition, we are in the process of evaluating the overall boom design, with specific emphasis on the pin tube design, in order to come up with a solution that will both strengthen the boom and make it less susceptible to failures due to unobservable defects in the welded areas.

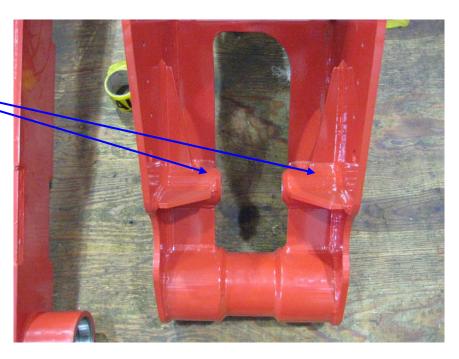
Figure 2

- 1. Conduct inspection of the wrench following the below steps.
  - a. Extend the wrench out far enough so that the vertical can be fully lowered down and carefully set on the floor, without putting stress on the vertical cylinder.
  - b. Disconnect power. Follow local tag out and lock out procedures. Remove any valve hand controls if installed.
  - c. View main boom from underneath with flashlight and inspect main pin tube and supporting gussets for cracks in the welds. Clean the area around the pin tubes and support gussets if necessary for better visibility
  - Using a step ladder and flashlight, perform similar inspection from above main boom.
  - e. Inspect pin tube and weld from the outside on both sides for cracks or evidence of buckling.
  - f. Figures 2 and 3 below indicate the areas of inspection.

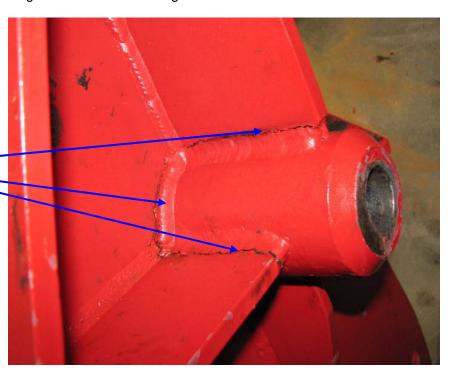
Figure 4

g. Evidence of cracking at the weld joints between the pin tube and support gussets is indicated in Figures 4 and 5 below.

Weld Joints to be Inspected

- 2. If you find evidence of cracking at the weld joints similar to that depicted in the above images, contact the Canrig Service Support Department immediately for an assessment. Contact information is provided below.
- 3. Failure to identify the problem and have it promptly corrected could potentially damage the equipment and, if not dealt with, could potentially become a hazard to personnel.

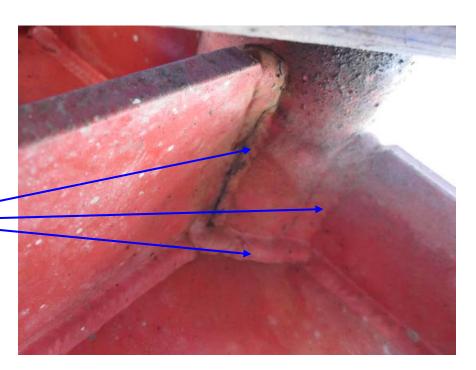
Figure 5

Weld Joints to be Inspected

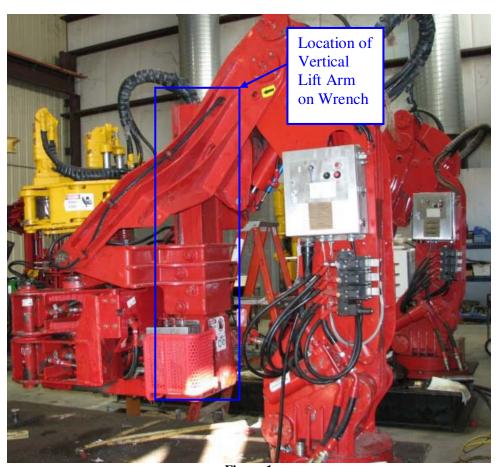
In a few isolated instances, rig crews have discovered cracks in the Vertical Lift Channel located approximately one third to halfway from the base of the channel. Probable cause of these cracks is most likely a result of repeated excessive loading or a singularly large impact load beyond normal operation of the wrench.

Figure 1 and Figure 2 indicate the areas of inspection for cracks on the Vertical Lift Channel.

- 1. Conduct inspection of the wrench following the steps outlined below.
  - a. While the wrench is in or close to the park position, fully raise the Vertical Lift Assembly
  - b. Disconnect power and follow local lock out and tag out procedures and remove any valve hand controls if installed.
  - c. Inspect the upper half of the Vertical Lift Channel for any sign of cracks. Clean the area in the channels for greater visibility if necessary.
  - d. Reconnect power to the wrench to move the assembly so that the bottom half of the Vertical Lift Channel can be inspected.
  - e. Extend the wrench out far enough so that the vertical can be fully lowered down and carefully set on the floor, without putting stress on the vertical cylinder.
  - f. Disconnect power. Follow local lock out and tag out procedures.

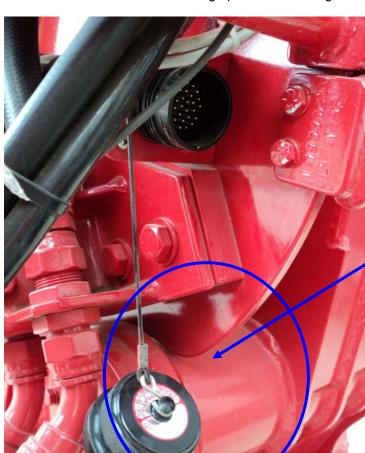
Figure 1

cable which connects the PLC control panel to the wrench arm junction box are supplied with protective cap plugs. Once the cable is connected to the receptacle, these cap plugs (hereafter referred to as the receptacle cap and cable cap) will hang loose and have the potential to become pinched between the

wrench main boom and base during operation. See Figure 1.

The receptacle cap and cable cap can become trapped and crushed here.

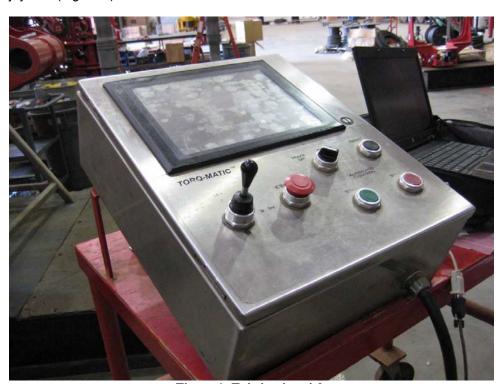
Figure 1: Existing joystick

There is a potential for the wrench to be accidently moved if the Driller's Console Joystick is bumped by personnel. A locking joystick is now available as a replacement that would mitigate this potential problem. The new joystick requires that the user pull-up on a sliding mechanism to engage joystick operations.

Replace existing joystick (Figure 1) on the Driller's Console with the new locking joystick (Figure 2).
