Product Bulletin # TM-021

Torq-Matic Floor Wrench Undercarriage Capscrews

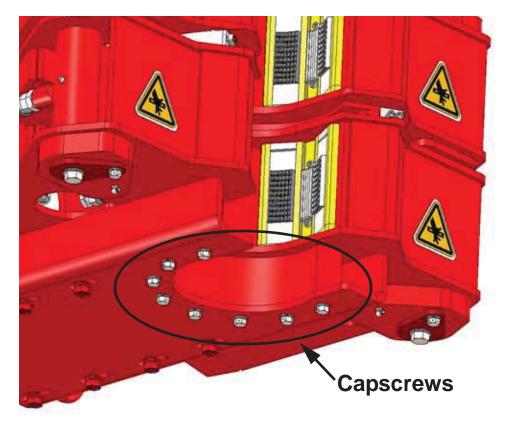
Figure 1: Undercarriage capscrews

One or more of the eight undercarriage capscrews (See Figure 1), attaching the lower tong frame to the vertical lift frame, can shear or work loose as the result of a high impact load that is outside of normal operating conditions. Without preventative maintenance, cyclic loading and/or vibration can also loosen or shear the capscrews over time. Preventative steps should be taken to ensure that all capscrews are properly installed and torqued to avoid loosening and/or shearing of capscrews and the potential separation of the entire tong and spinner assembly from the vertical lift assembly.

The likelihood of loosening and/or shearing capscrews increases if a high impact load is experienced or repeated attempts are made to clamp the lower tongs onto a tool joint with the wrench assembly not level to the ground.

Verify all capscrews are properly installed and torqued to 99 ft-lb (Use a torque wrench). Canrig recommends replacing all capscrews if any of them are loose, missing, damaged, or sheared as there may be unseen damage to the threads of the installed capscrews. Replace with new capscrews and Nord-Lock washers. Apply Loctite Threadlocker Blue 242 to replacement capscrews prior to installation. Wire capscrew heads together to prevent loose capscrews from falling out.

Inspect daily for loose, missing, damaged, or sheared capscrews. Ensure the wrench assembly, consisting of the tongs, spinner, and vertical lift is level to the ground. See the parts list below for replacement parts. Contact RigLine 24/7[™] for assistance.
