Product Bulletin # DW-014 Rev 1

## **DW2000 MD Splash Protection**

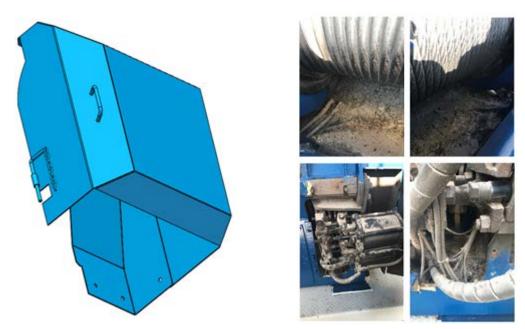
- Some of the drawworks have failed the static brake tests due to contamination on the brake disc and/or the brake pads. This is likely from water, mud, oil, etc., getting inside the brake guards during power washing of the drawworks and other operations. There is currently some splash protection, but the bottom of the guard is open. There are no drain holes in the skid deck, allowing liquids to pool on the skid deck.
- The solution involves adding drain holes to the skid and covering the bottom of the guards. A drawing, AY28904 (Figure 3 on page 4), was created to upgrade the units in the field.

The original guard door design included an open bottom to allow drainage and air flow for the caliper brakes. During field use, it was determined that this design would allow contaminants to enter the base of the drawworks. See Figure 1.

Figure 1: Original door design on the left, contaminants trapped in the bottom of the drawworks on the right

Update the guard doors to include the splash protection and add drain holes to the skid deck. Refer to AY28904 (Figure 3 on page 4) for the new door part numbers and locations for the drain holes.

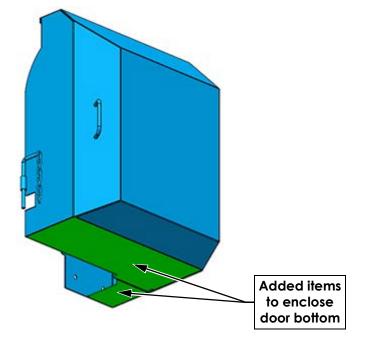
Figure 2: Updates to existing guard doors

Refer to AY28904 (Figure 3 on page 4) for the procedure for field installation of drain holes on skid. Updated enclosed door to eliminate the ingress of contaminants is shown on Figure 2.
