TOP DRIVE PRODUCT BULLETINS ARIG (Δ DRILLING TECHNOLOGY LTD.

CANRIG TD PRODUCT BULLETIN MANUAL

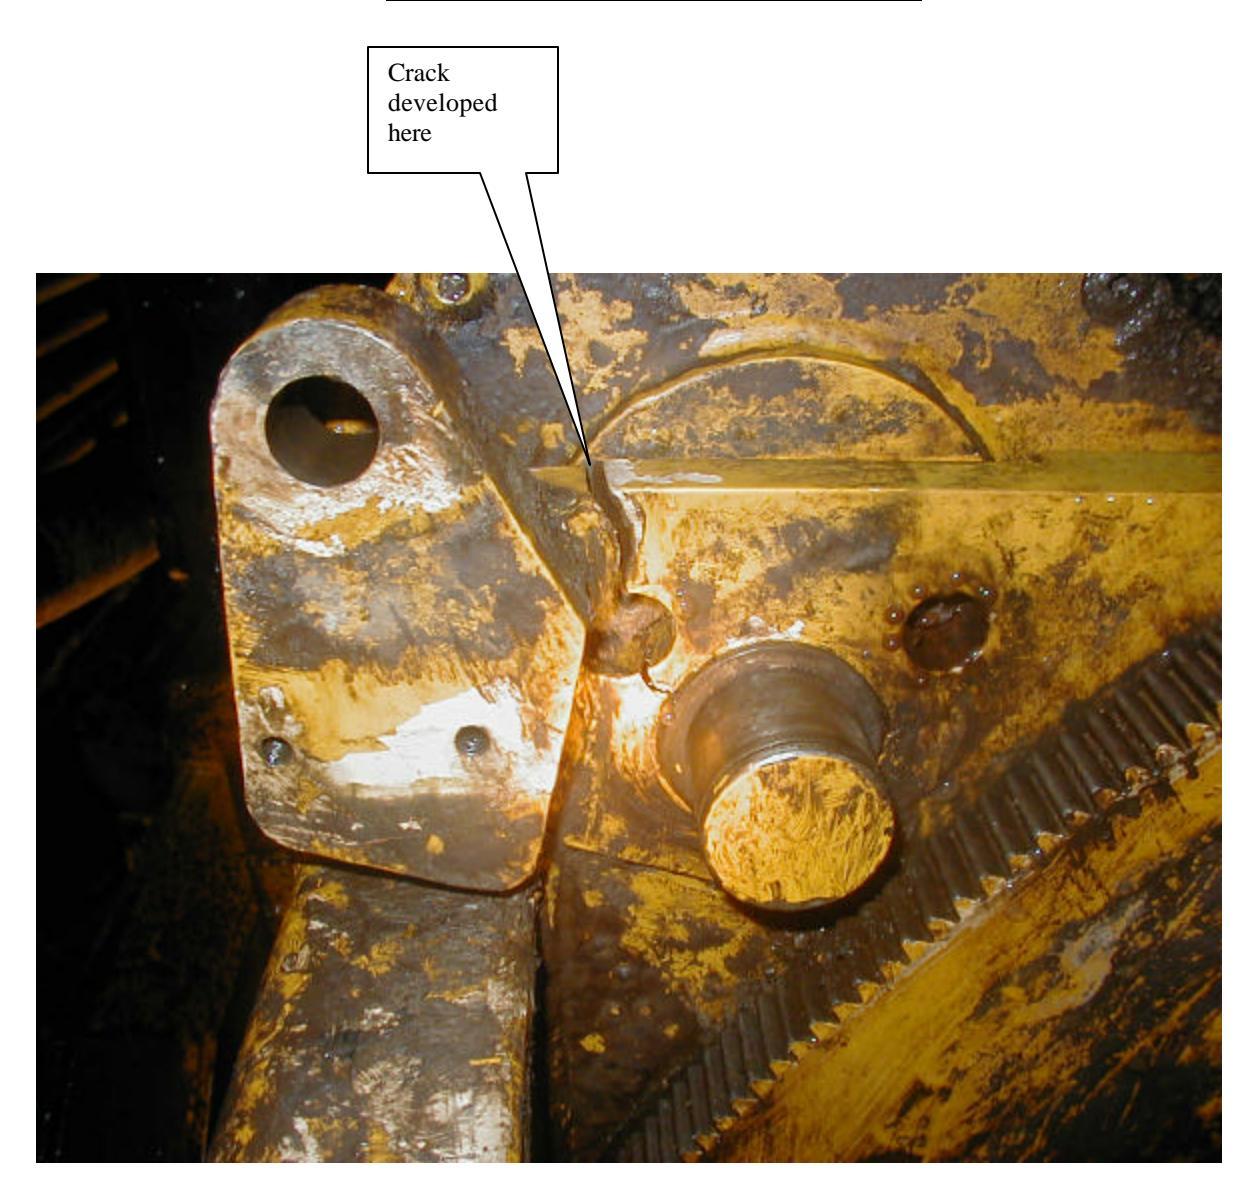
Picture of cracked mounting plate

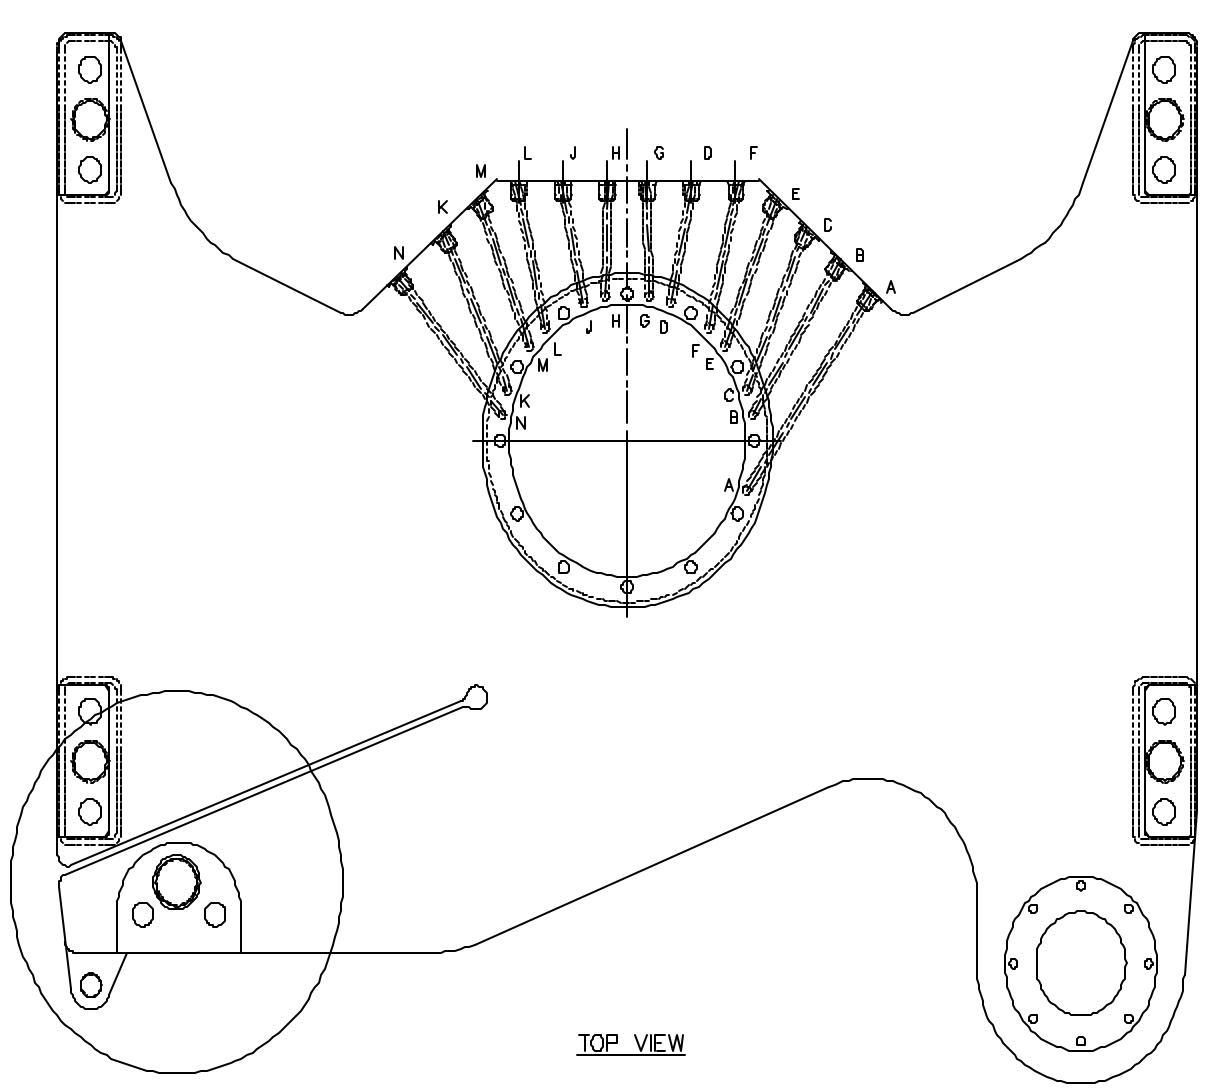
```
Area where cracks may develope
```

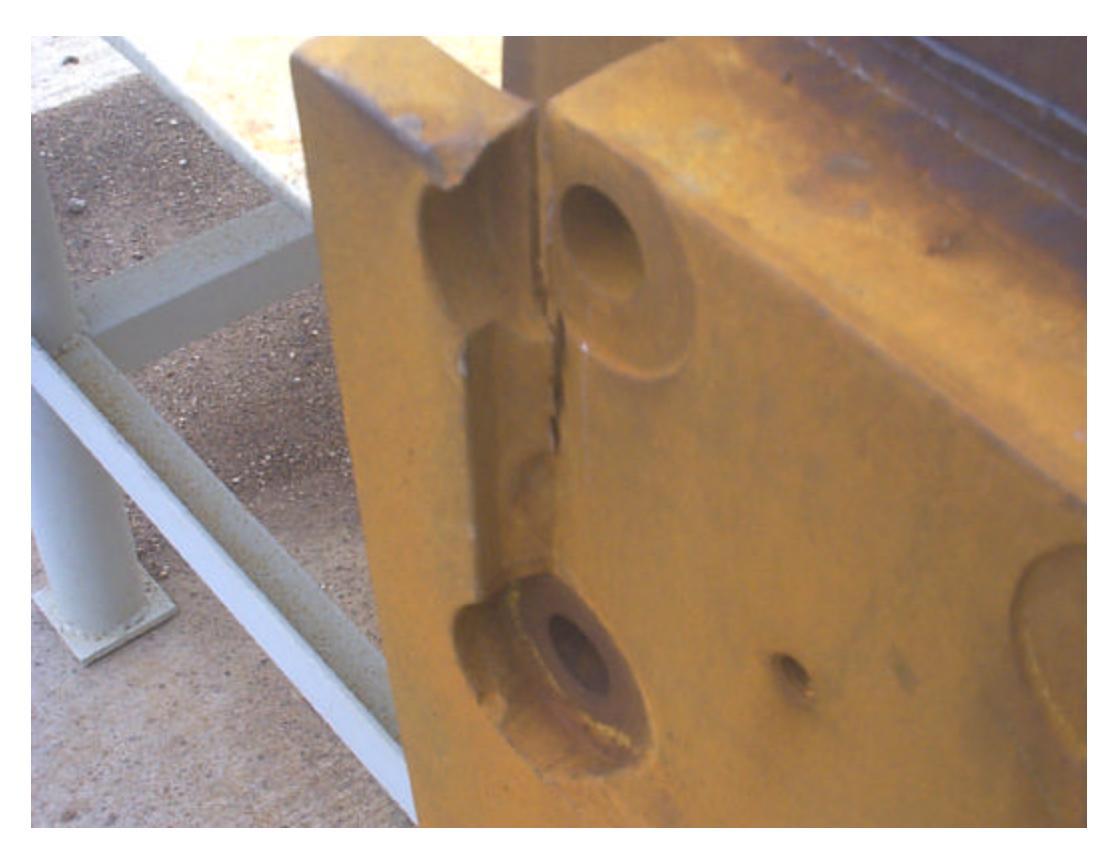
Figure 1: Typical Crack in a Slide

The slide is generally cracking at the weld joining the slide's bottom plate (1) to the center block (2) that is welded to the inner tube as shown below in Figure 1.

- 1. Remove the existing fillet weld where the crack is present down to the base material using grinding or gouging method. It is essential that the crack is completely removed.
- 2. Dry-MPI the crack area completely by going past the end of the crack to ensure that the crack is completely removed.
- 3. Make a 3/8" fillet weld using Low Hydrogen E7018-1/8" rod or equivalent (see Notes) along the prepped area as shown in figure 5.

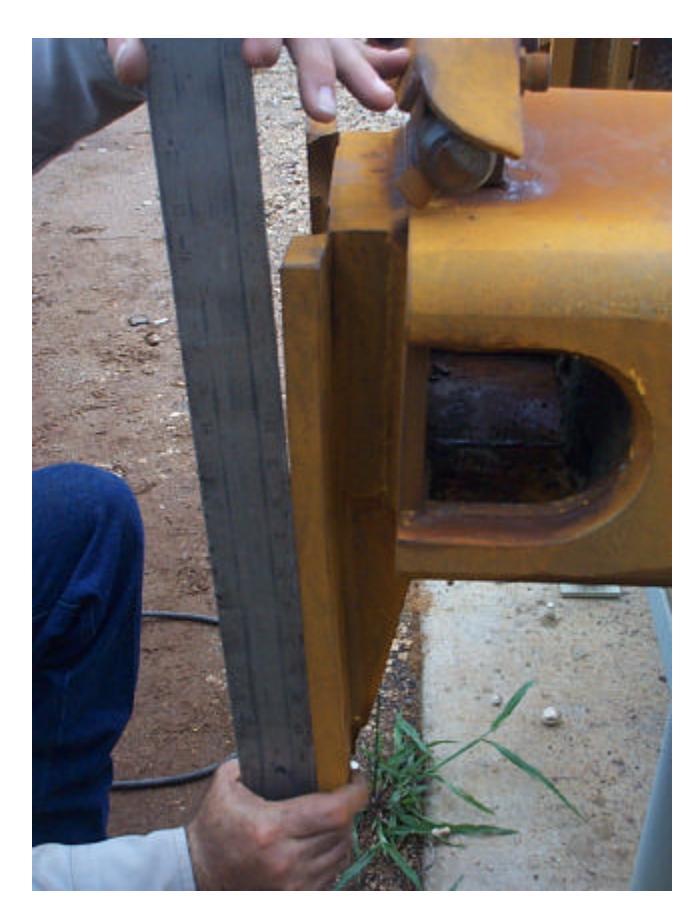
Figure 2: Bent Bottom Plate

The cause of the crack may result in bending the slide's bottom plate (1). **The BUW inner tube assembly must be replaced if the bottom plate is bent in excess of 1/8''.** To check the slide's bottom plate, use a straight edge and place on the bottom of the slide as shown in the picture of Figure 2.

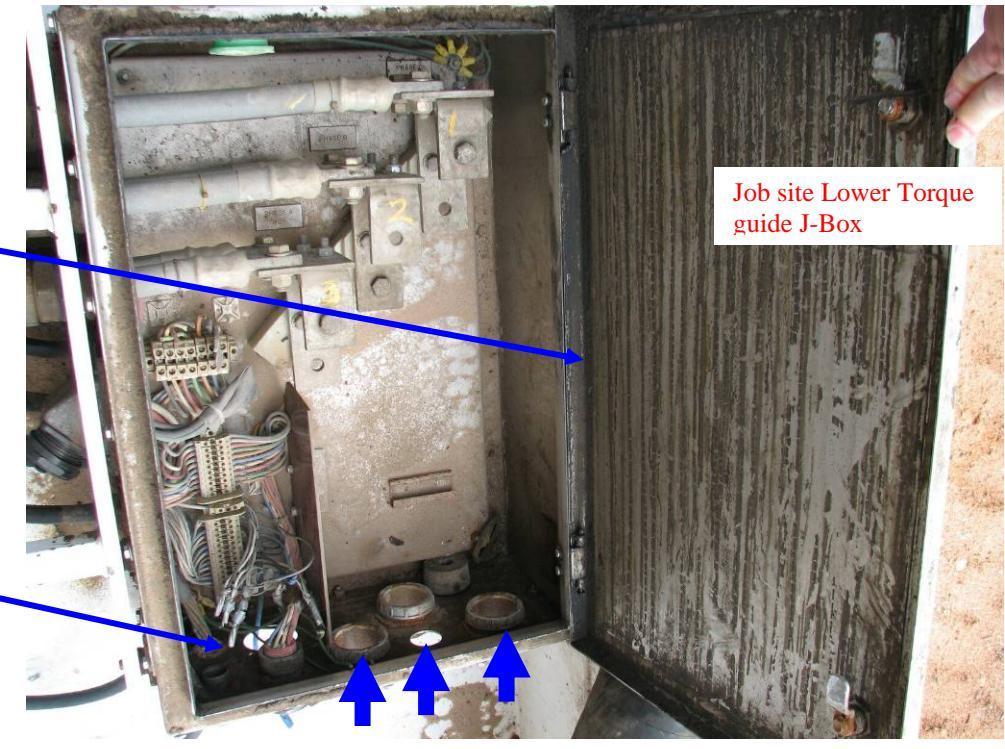
Missing gasket seal from _____ door.

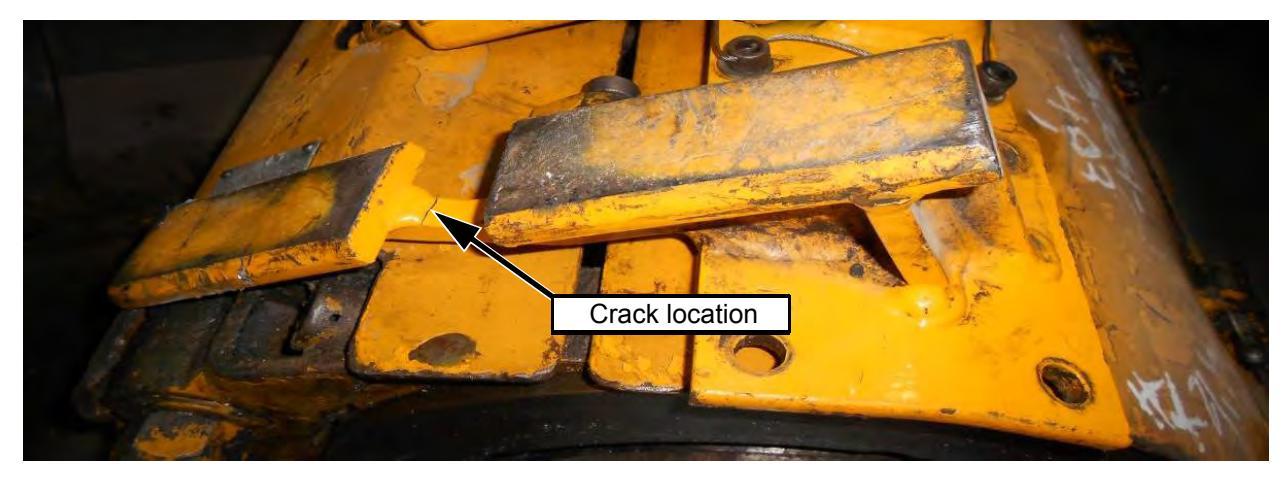
Figure 1: Cracked LWCV Anti-Rotation Bracket (Part # DT16711)
