TOP DRIVE PRODUCT BULLETINS ARIG (Δ DRILLING TECHNOLOGY LTD.

CANRIG TD PRODUCT BULLETIN MANUAL

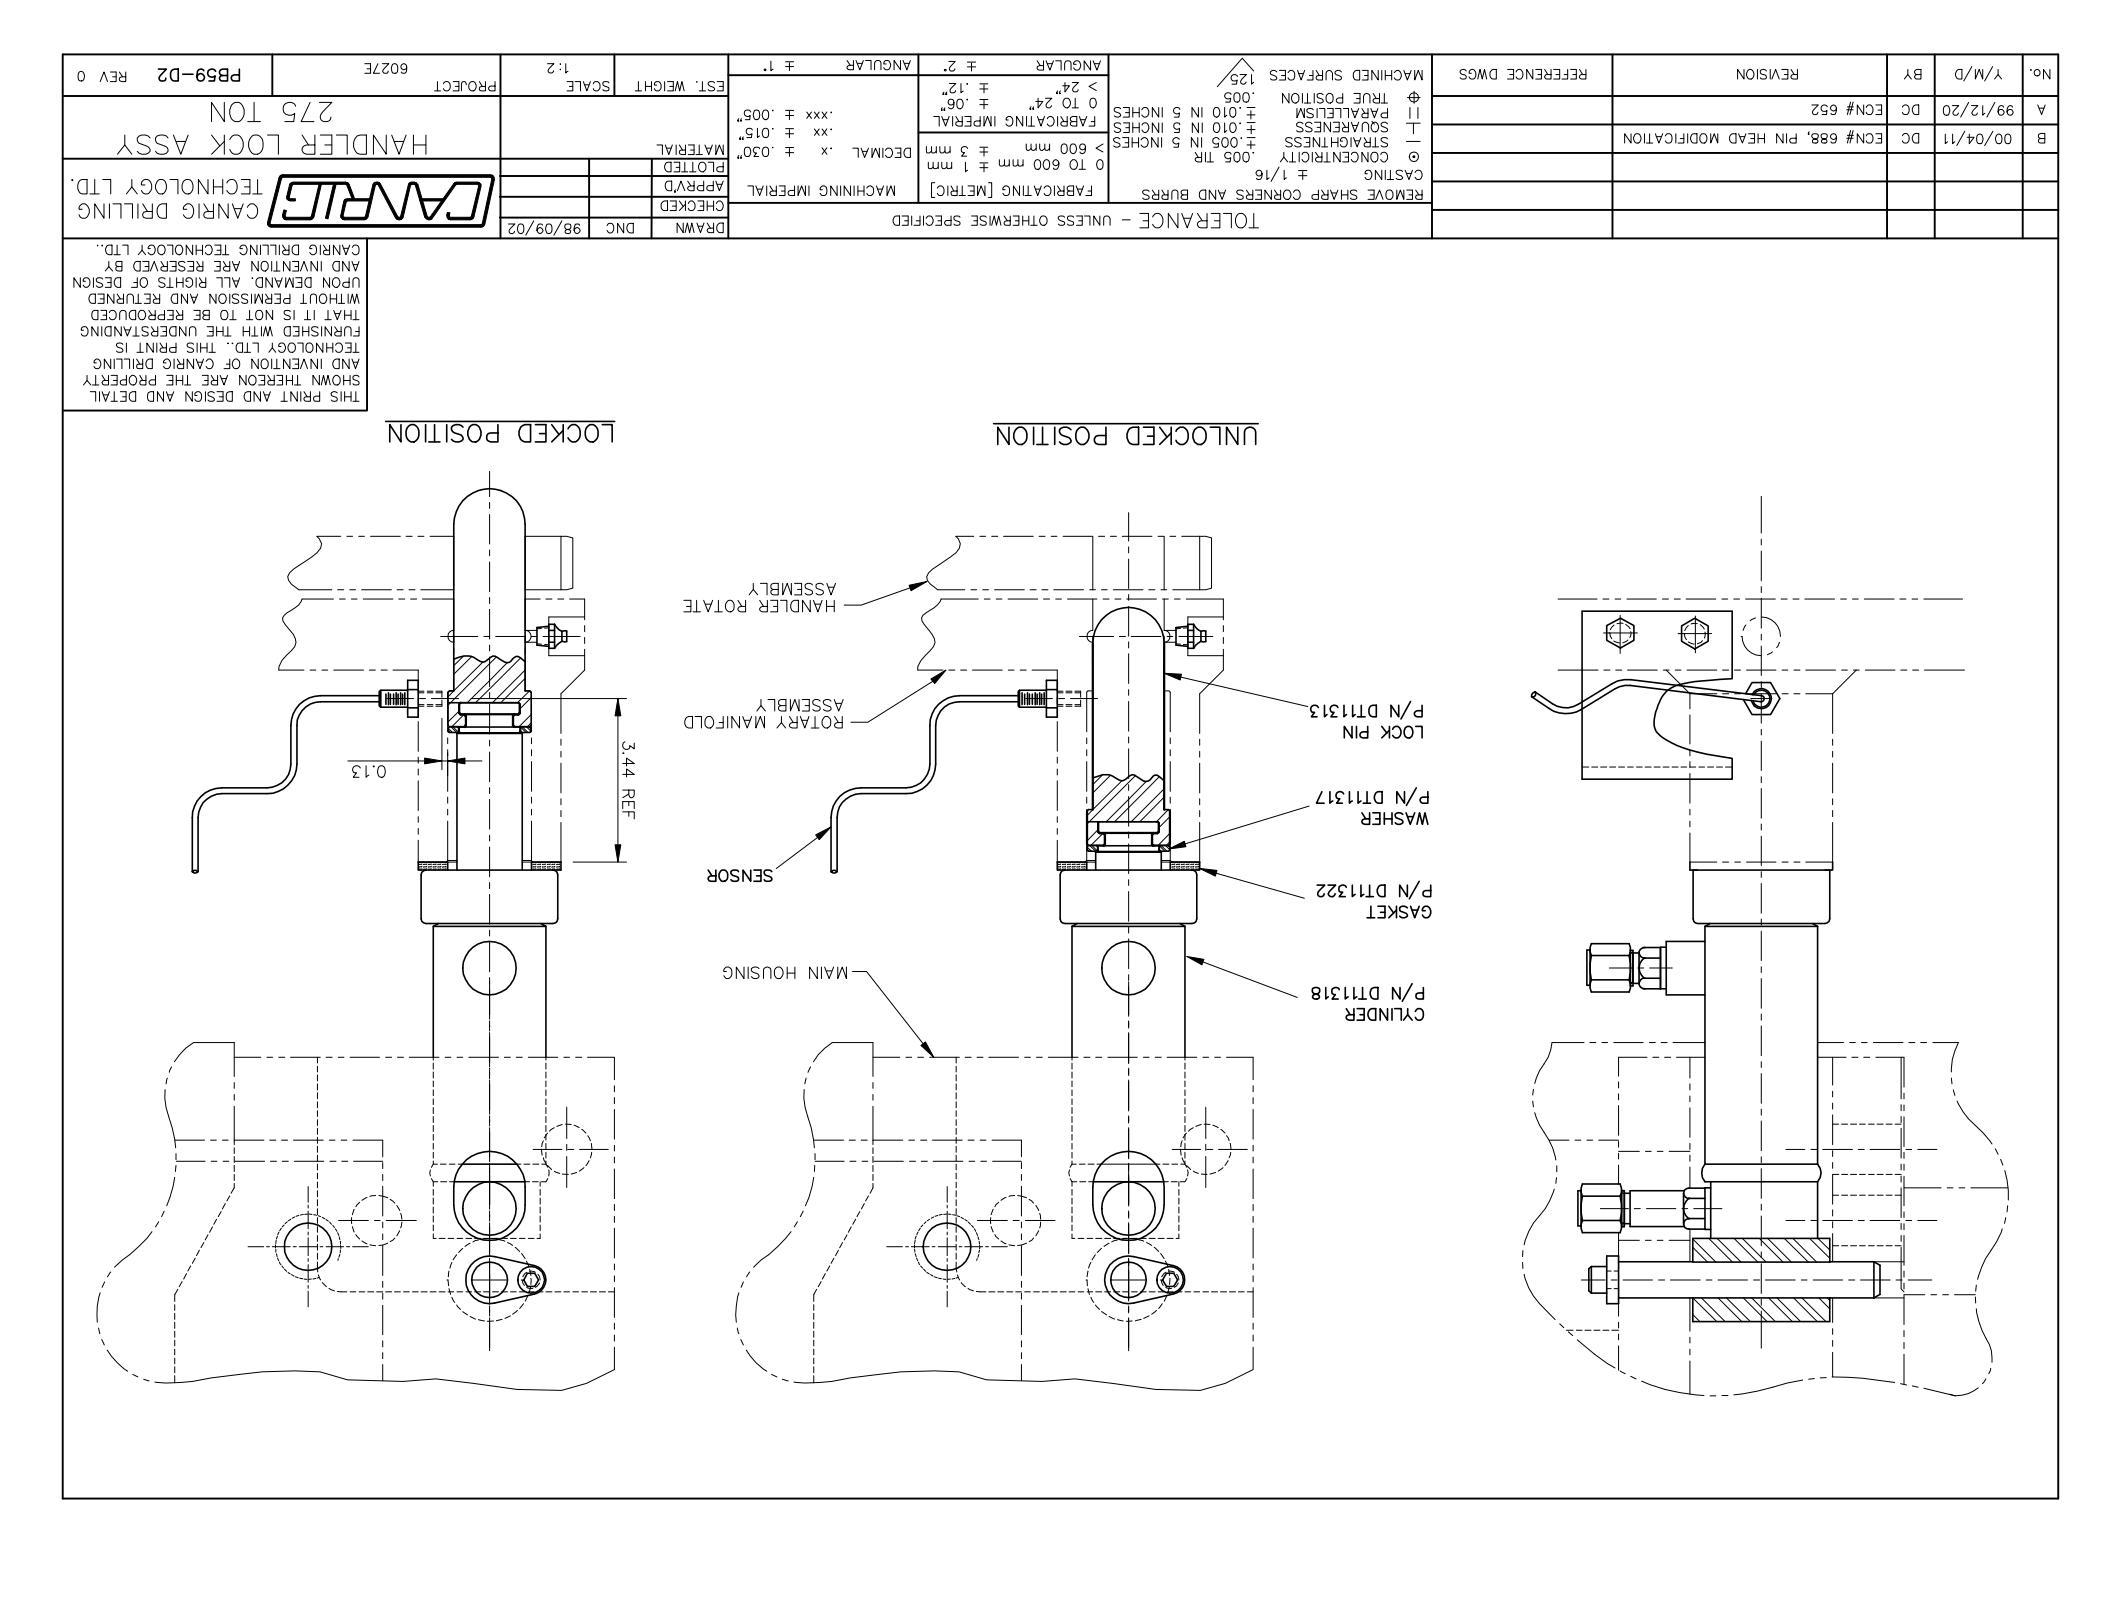
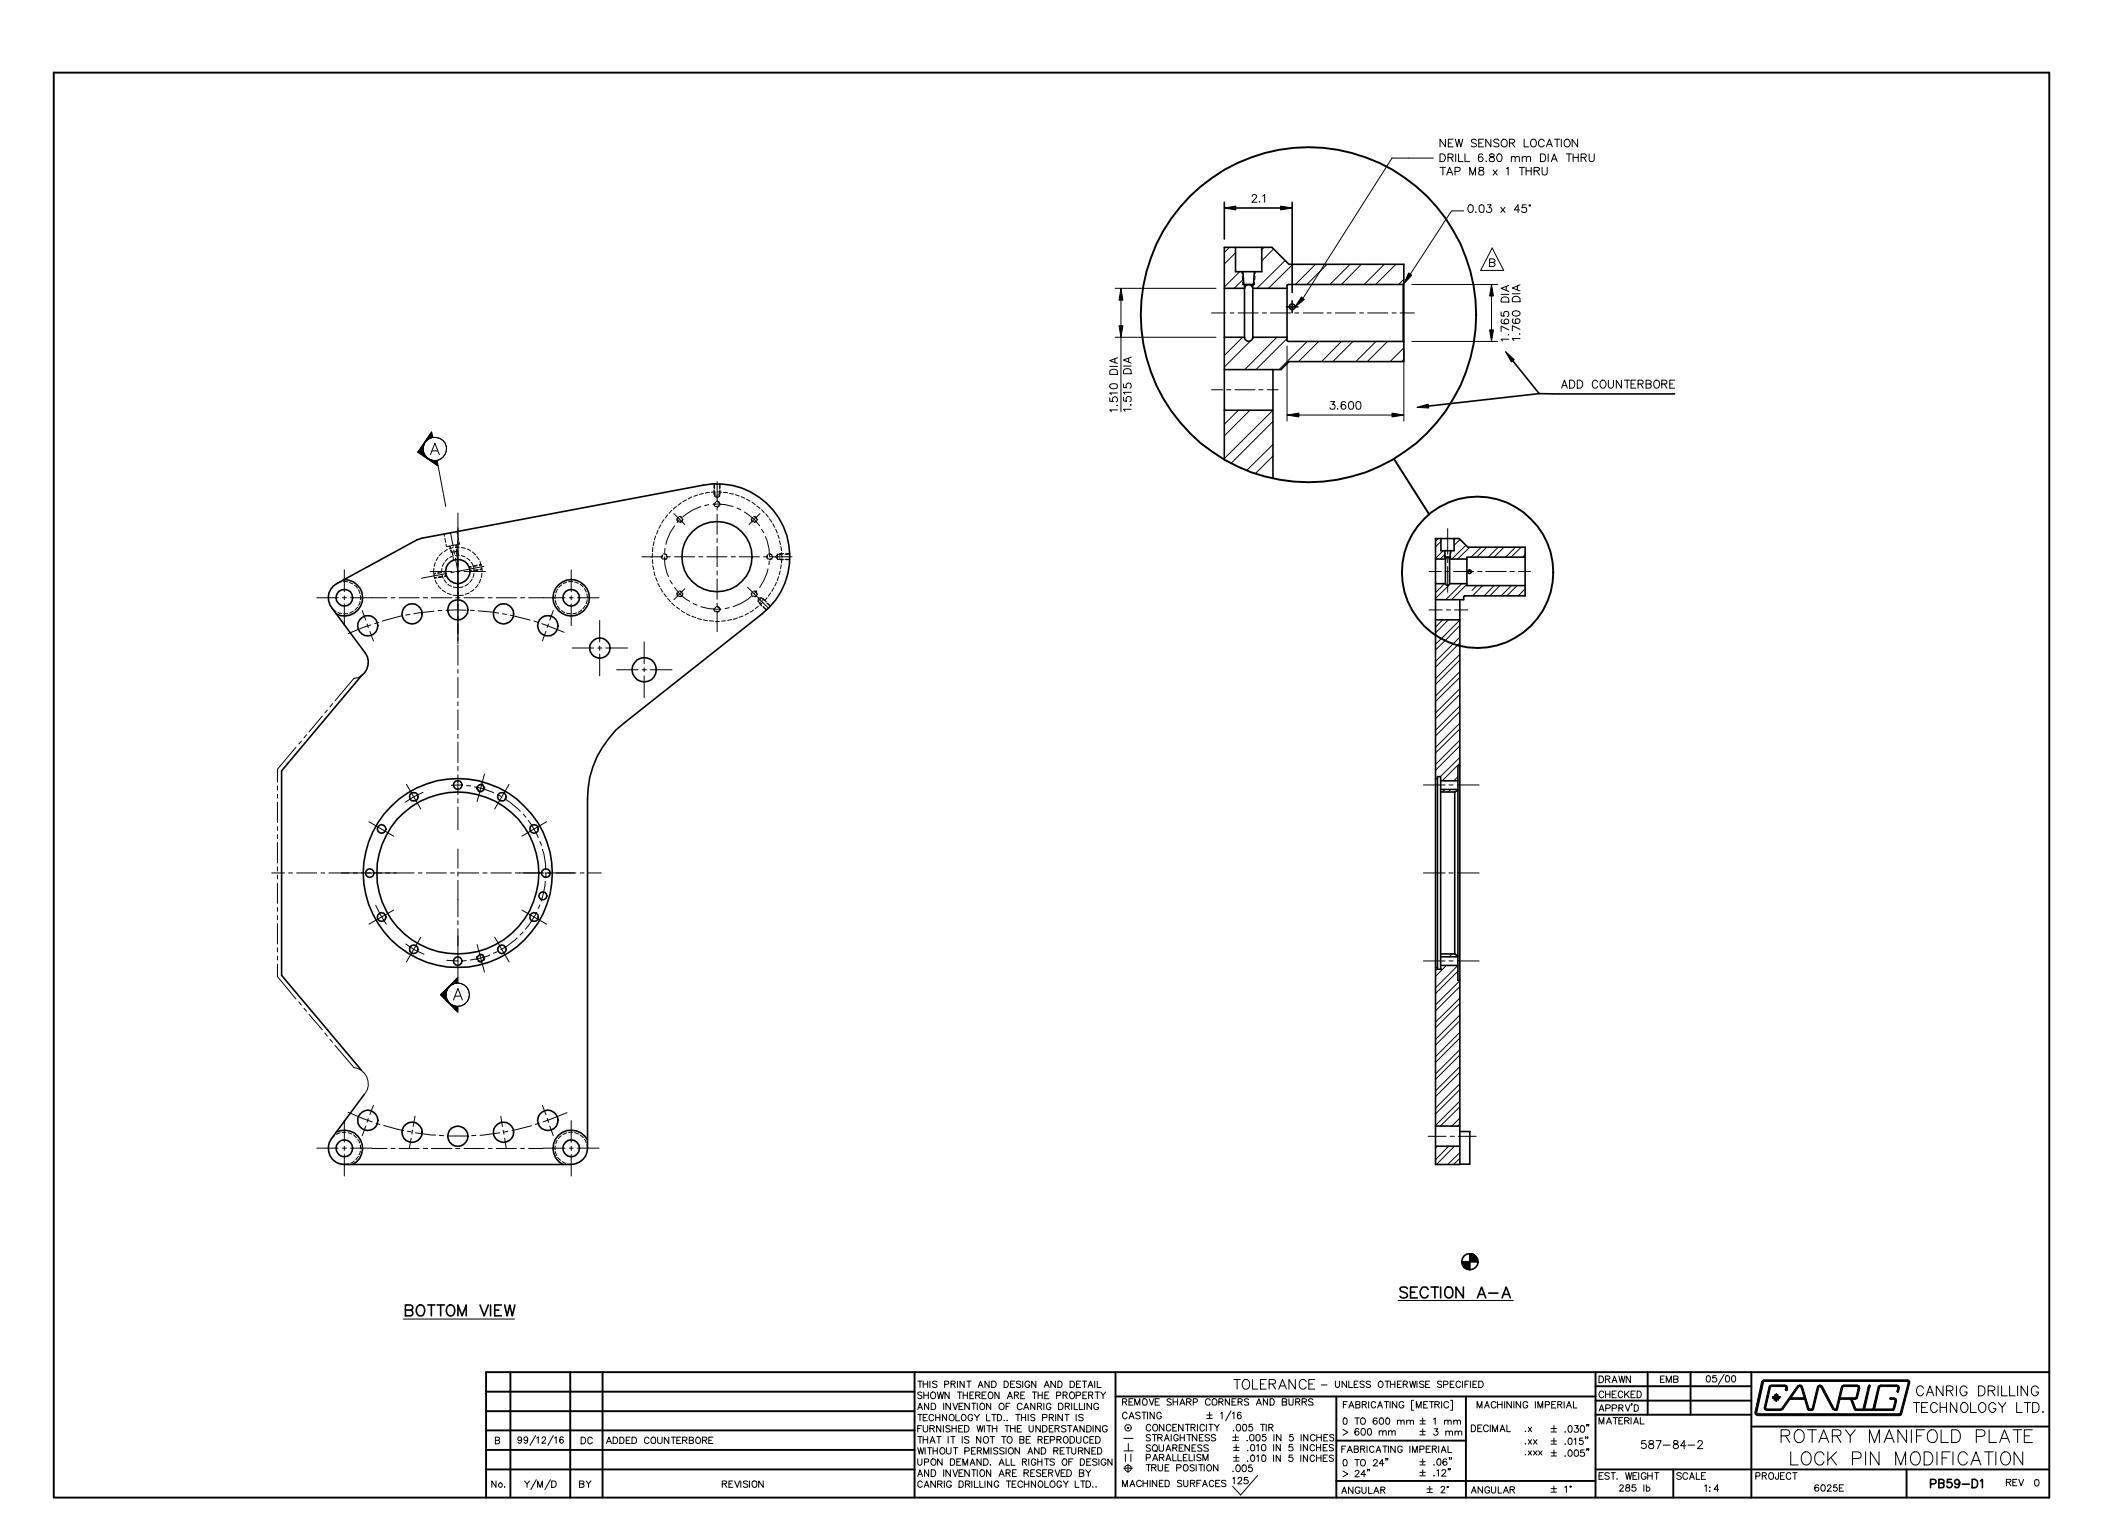
SUBJECT:	275 TON HANDLER LOCK PIN (Model 6025, 6027)
SERIAL NUMBERS:	013, 030, 036, 041, 047, 049, 062, 071, 076, 092, 097, 111, 116, 123, 124, 132, 138, 139, 144, 145
DISCUSSION:	Over time, it may be possible for the Handler Lock Pin to become partially or fully unthreaded from the Handler Lock Cylinder rod. If the connection is not properly tightened, this could result in a failure of the pin to cylinder rod connection. It is then possible for the Lock Pin to fall from the Top Drive. The lock pin and bore can be modified to include a shoulder that would prohibit the pin from falling from the Top Drive in the event that the cylinder rod was to break. The cylinder rod has also been modified to reduce the stress where it connects to the lock pin. See assembly drawing PB59-D2.
RECOMMENDATION:	The full modification should be completed at the earliest opportunity such as a rig move. The rotary manifold plate will have to be removed and the lock pin bore machined to include a shoulder as shown on drawing PB59-D1. A new pin (P/N DT11313) and cylinder (P/N DT11318) should then also be installed. As a temporary measure until the full modification can be completed, a 1/8" hole can be drilled through the pin and cylinder rod and a roll pin installed to prevent the lock pin from unthreading (see drawing AY10986).

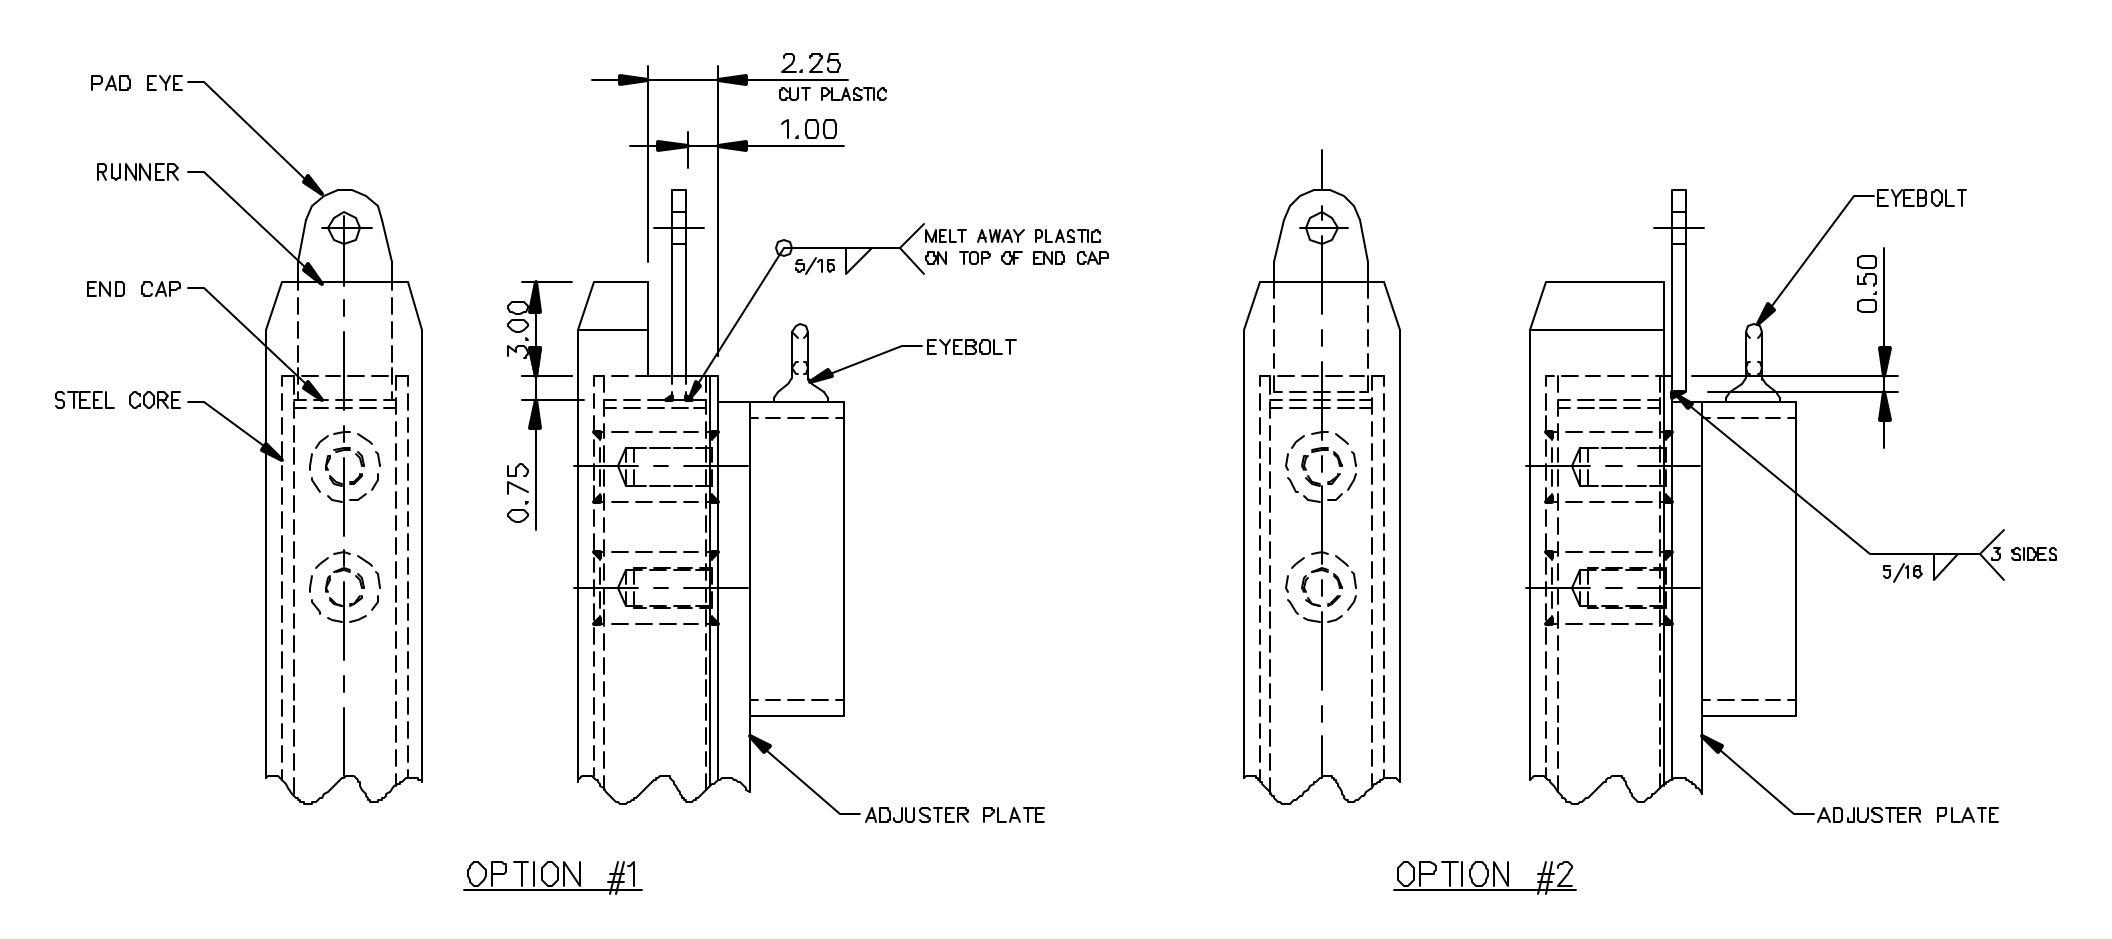
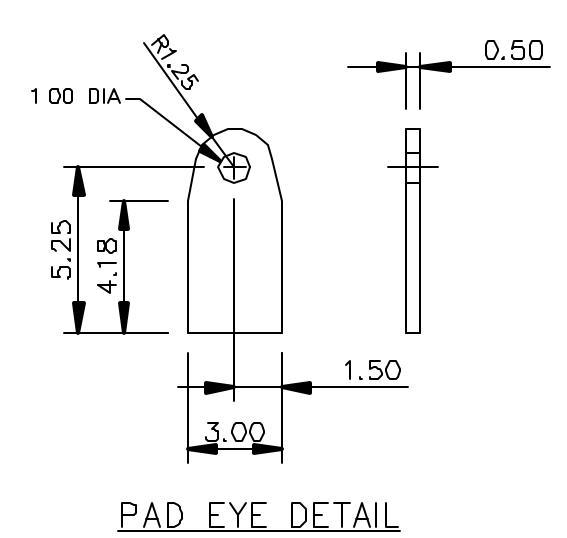
SUBJECT:	RETRACTION FRAME/ GUIDE RUNNERS		
SERIAL NUMBERS:	135, 136, 137		
DISCUSSION:	Improper securing of guide runners and all related fasteners could result in the runners or fasteners falling free.		
RECOMMENDATION:	 All fasteners on the retraction frame assembly should be inspected for proper torque value and safety wire. The guide runners are not currently secured properly. They should be secured by one of two ways: 1) Cut off the top 3" of plastic from the top end of each runner. Drill and tap the top end cap of the runners ½". NOTE: The steel end cap is located approximately ¾" below the top of the cut runner. Thread a ½" eyebolt into the top of each runner and secure to the eyebolt on top of the adjusting plate with ¼" wire. 		
	 Weld a pad eye to the top of each runner on the face that fits against the adjusting plate. The steel core of the runner extends above the top of the adjusting plate by ³/₄". The pad eye should be welded to steel core of the runner at this location. Secure the runners to the eyebolt on top of the adjuster plate with ¹/₄" wire.

And Safety cables or wires that are removed to facilitate repairs must be reinstalled prior to operation of the Top Drive or Retraction Frame.

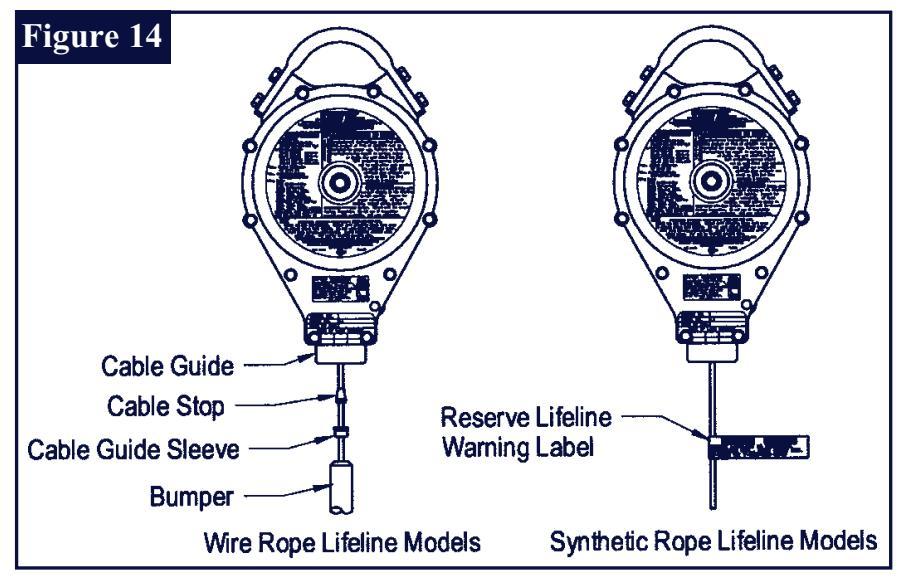
SYNTHETIC ROPE MODELS (Spectra and Technora): Inspect reserve lifeline payout. If a fall has been arrested, it is possible the reserve lifeline has been deployed. To inspect for reserve lifeline deployment, pull lifeline out of the SRL until it stops. If the reserve lifeline warning label is visible,

the reserve lifeline has been spent and the unit must be serviced by an authorized service center before use. See Figure 14. If the reserve lifeline has not been deployed (the reserve lifeline label is not visible) that portion is acceptable and the inspection can continue.

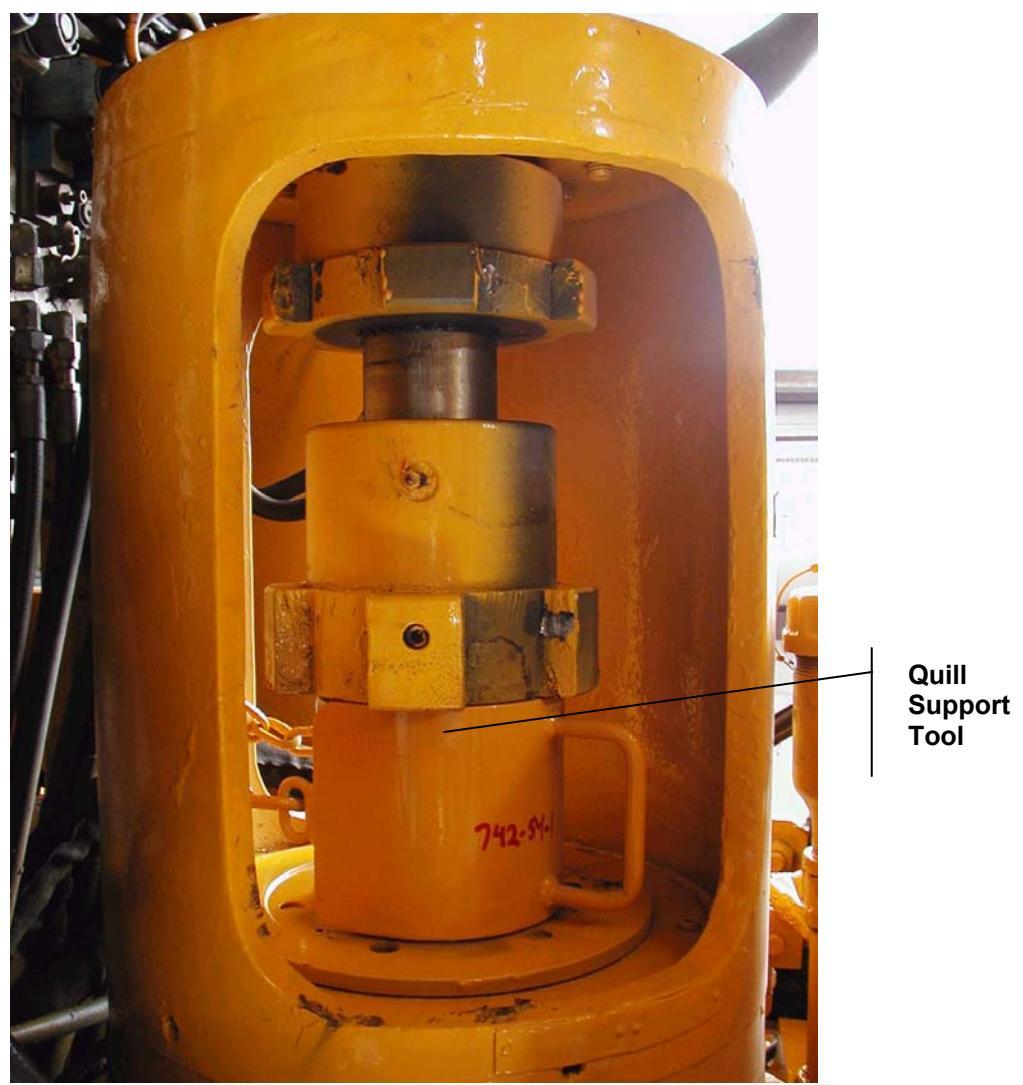
Fig. 1

- 1. Ensure the top drive is not connected to the drill string and is at floor level.
- 2. Fully extend the back-up wrench gripper so that it is below the threads of the lower well control valve.
- 3. If the gripper is not below the pin connection of the LWCV, float the quill up and install the quill support tool below the washpipe stuffing box. See Fig. 1. If the tool is not available, blocking can be used.

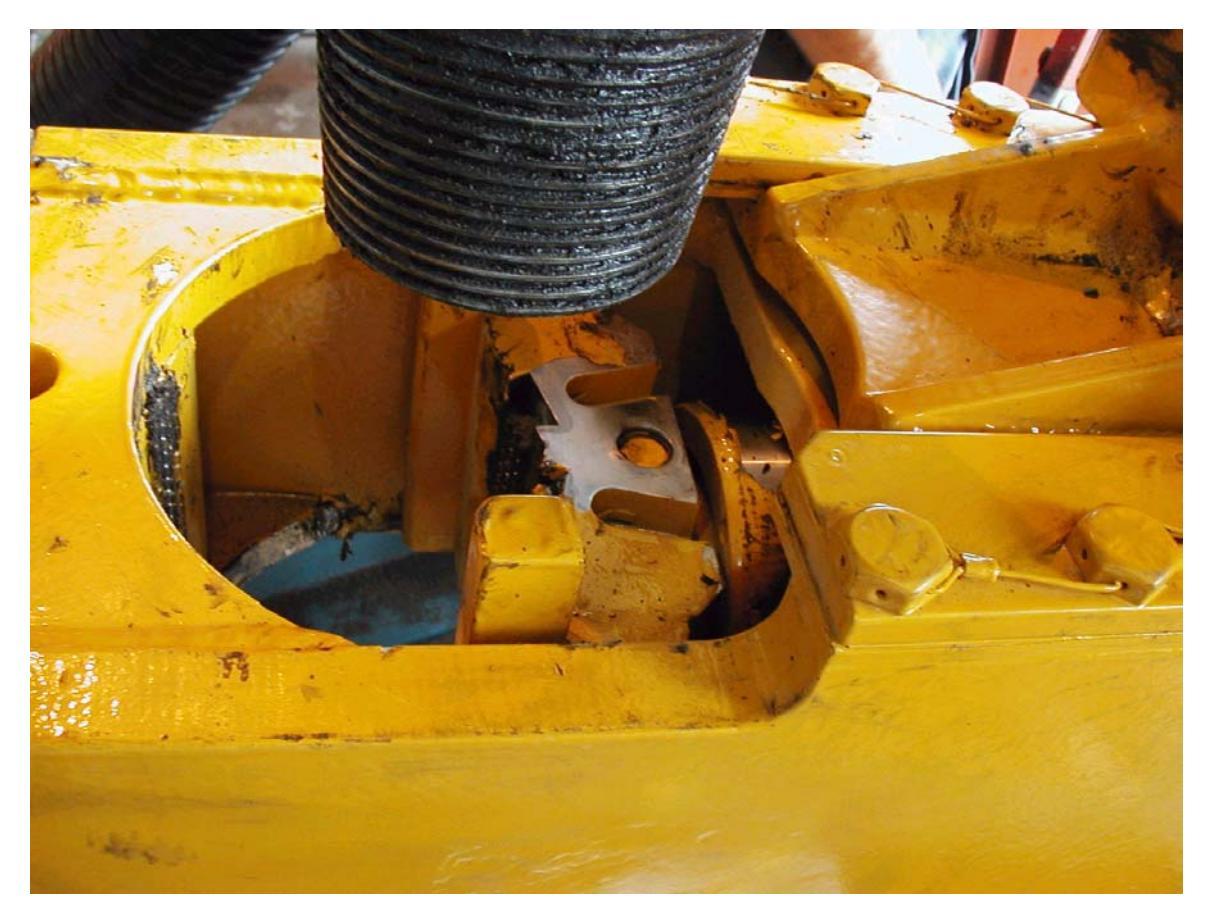
Fig. 2

4. Close the gripper by moving the switch/joystick to Gripper Maintain Closed. The gripper die block assembly should appear as it does in Fig. 2.

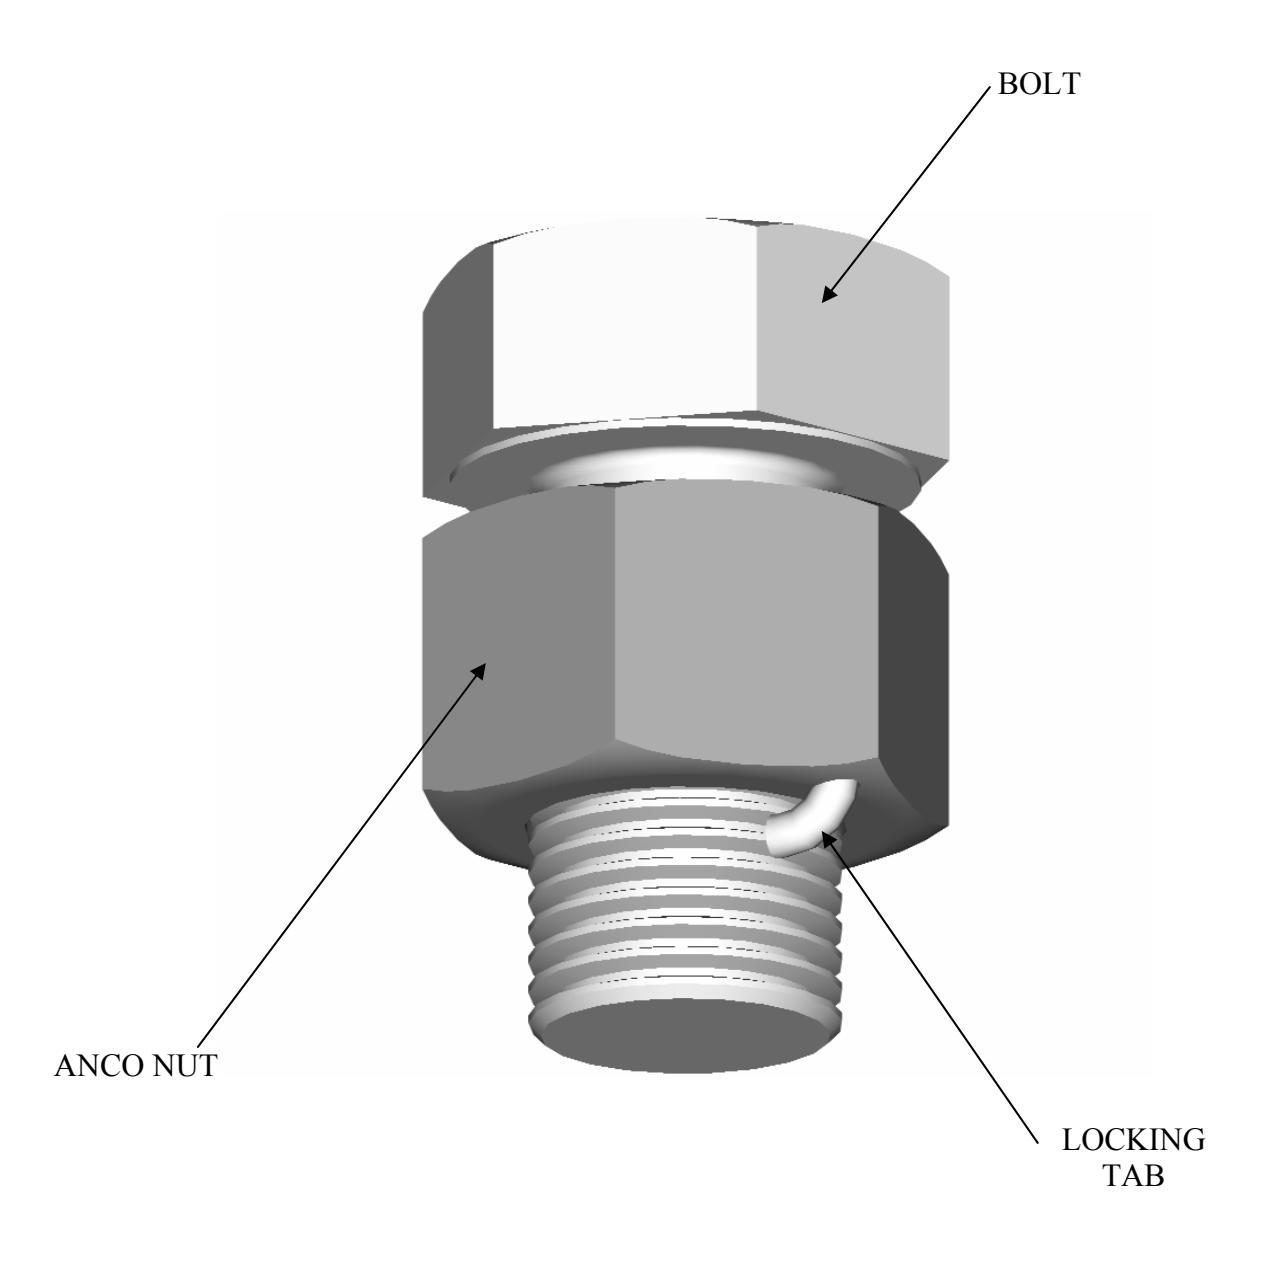
Figure 78.1

SUBJECT:	SECOND NOTICE: Proper use of Anco Lock Nuts	
SERIAL NUMBERS:	002 and Up	
DISCUSSION:	Anco lock nuts (See attachment Figure 78.1) are a galvanized construction and the thread profile is made to match with galvanized threads. These threads are not compatible with standard NC threads. These components are currently used on some torque reaction and rig interface assemblies.	
RECOMMENDATION:	 Use Anco nuts only with proper galvanized rod or bolt. Use Stover locknuts with B7 UNC threaded rod or bolt. When installing any locknut at least three threads must be extended past the outer most locking mechanism (locking tab in case of Anco). If this is not possible, replace the threaded rod or bolt with one of sufficient length and material.

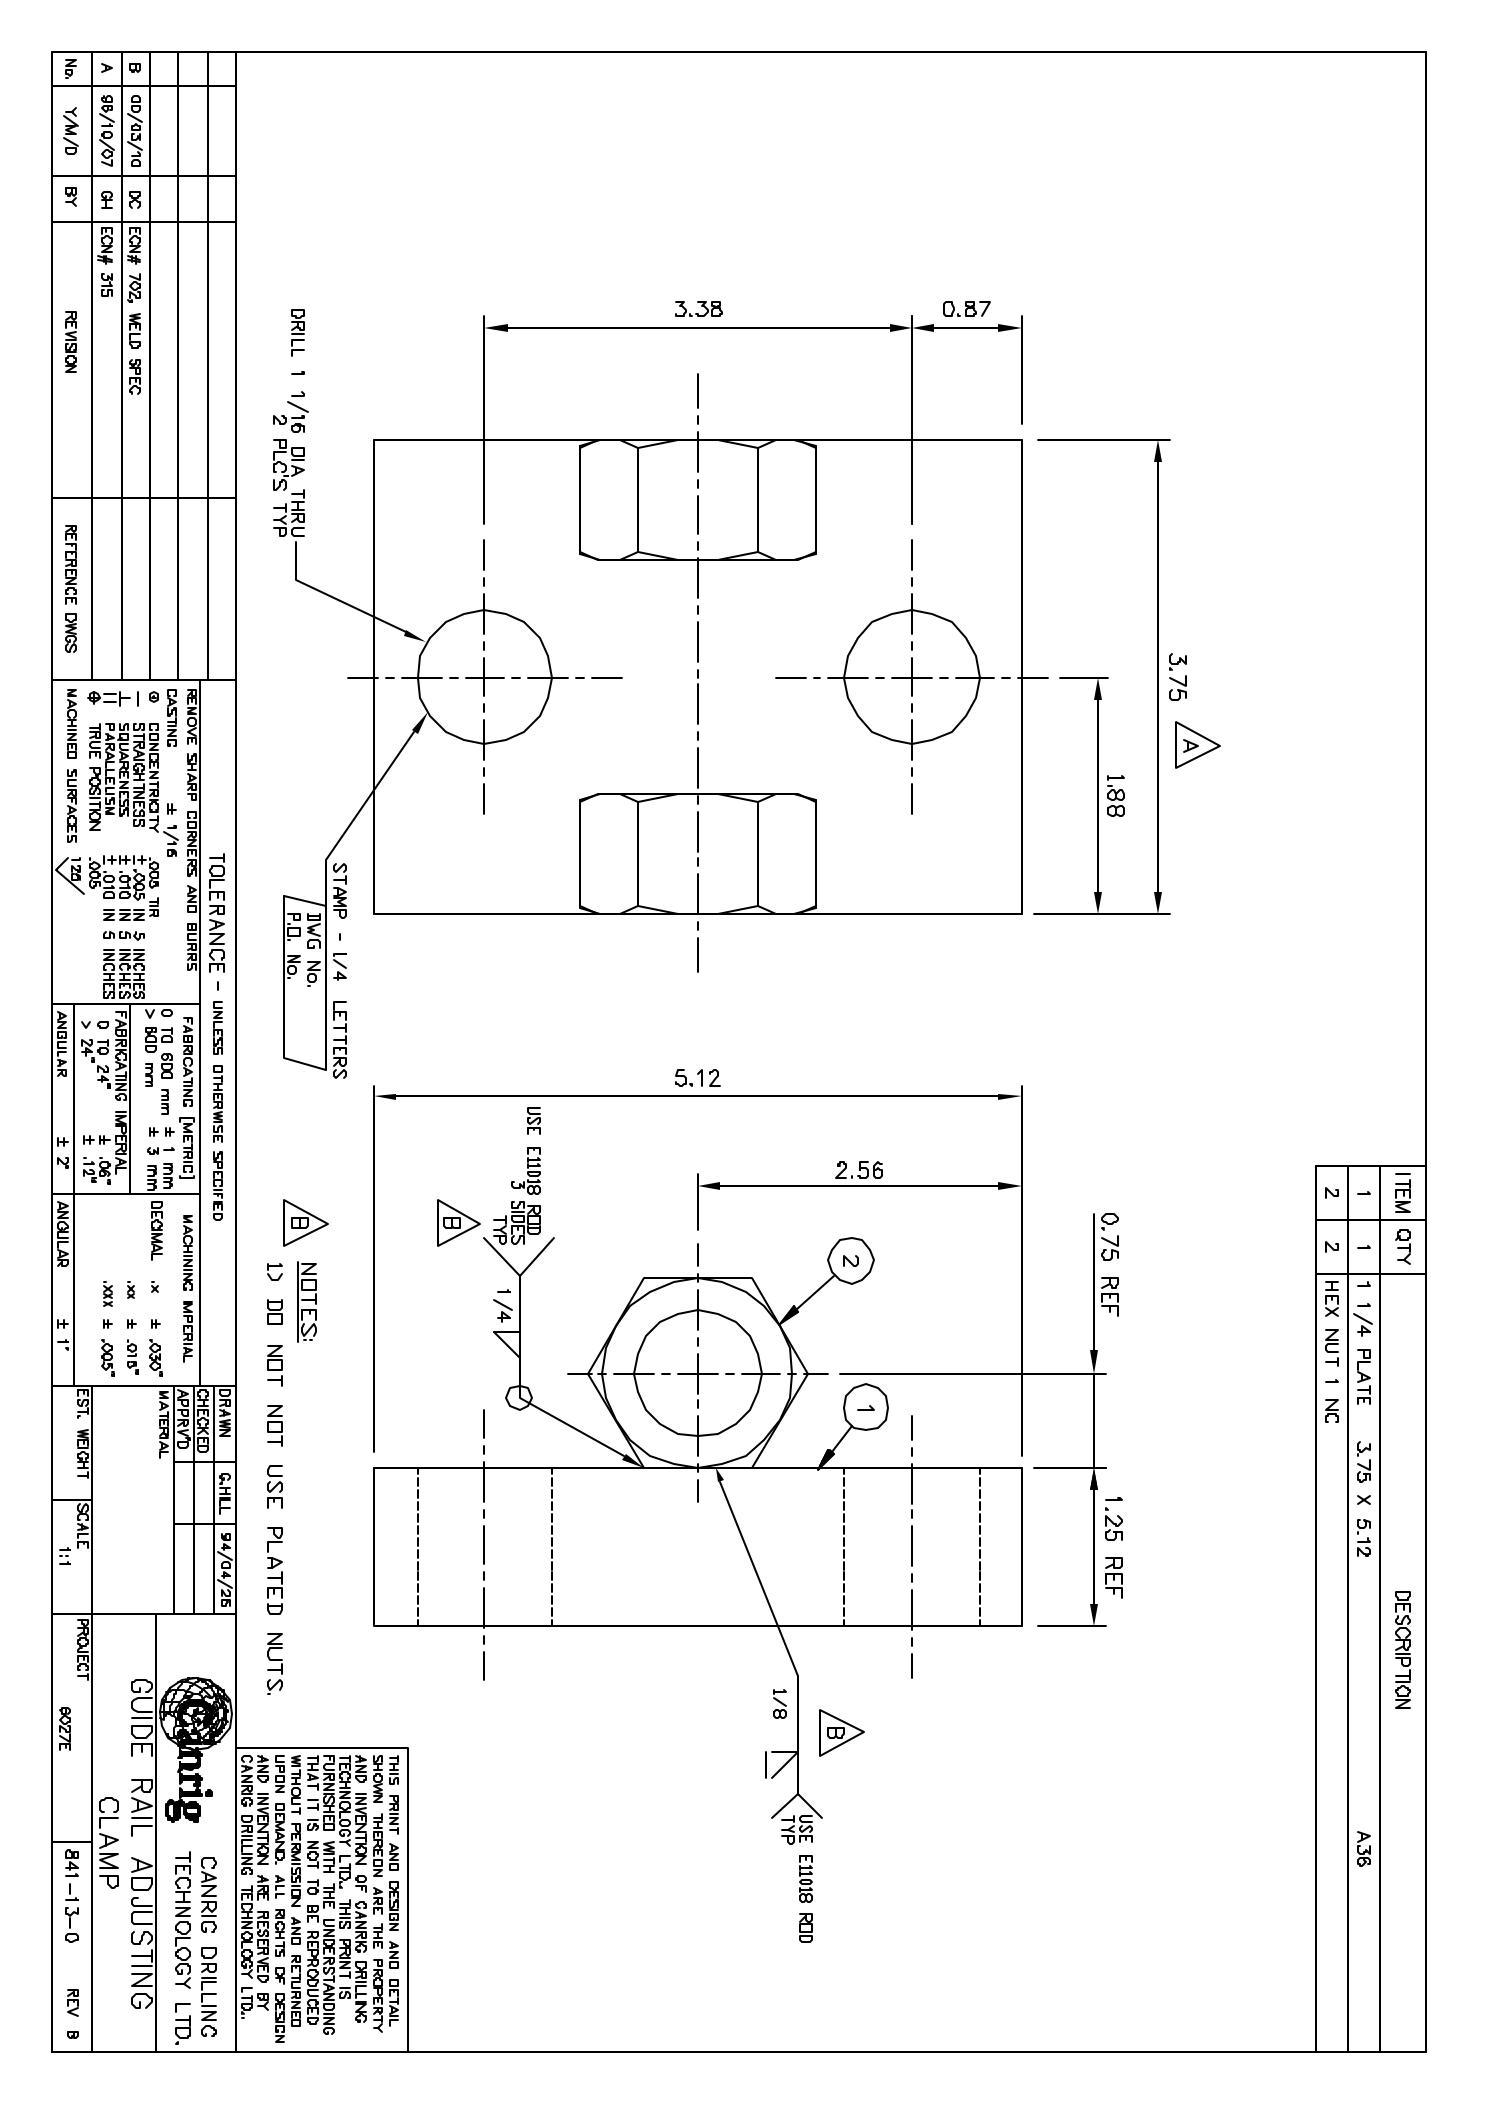
SUBJECT:	Guide Runner Adjuster Bolts
SERIAL NUMBERS:	014-185
DISCUSSION:	A near-miss incident was experienced when an adjuster bolt broke loose and fell from the Top Drive. The weld that held the nut of the adjuster bolt in place failed and caused the part to separate from the adjuster plate. Investigation showed that the nut was only welded on two sides
RECOMMENDATION:	<i>Inspect each adjuster nut for penetration welds on all four sides of the</i> <i>nut.</i> If you find any nuts that do not have adequate welding, upgrade the welding to match the specification (see attached drawing) or order the appropriate number of adjuster plates to rectify the situation. The part number for the adjuster plates is as follows:
	275 Ton Rail Adjuster Plate – 841-37-0, TD Adjuster Plate – 841-39-0
	350/500 Ton Rail Adjuster Plate – 841-12-0, TD Adjuster Plate – 841-13-0
	Should you have any questions or concerns, please do not hesitate to contact your CANRIG representative or the Field Operations Manager listed below. <i>IF in doubt, ask!</i>

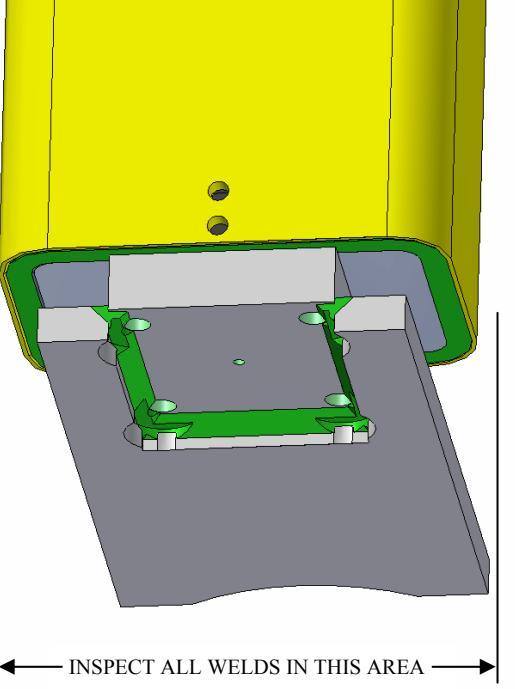
The slide is generally cracking at the weld joining the slide's bottom plate (1) to the center block (2) that is welded to the inner tube as shown below in Figure 1.

The cause of the crack may result in bending the slide's bottom plate (1). **The BUW inner tube assembly must be replaced if the bottom plate is bent in excess of 1/8''.** To check the slide's bottom plate, use a straight edge and place on the bottom of the slide as shown in the picture of Figure 2.

- 1. Remove the existing weld in the area where the crack is present, down to the base material using grinding or gouging method. To make sure that the crack is completely removed, it is necessary to grind past the visible crack.
- 2. Dry- MPI (Magnetic Particle Inspection) the crack area completely by going past the end of the visible crack. Ensure that the crack is completely removed.
- 3. If it was found that the crack was not completely removed or a new crack was discovered, grind the crack completely and Dry-MPI the area again to ensure that the crack is completely removed.

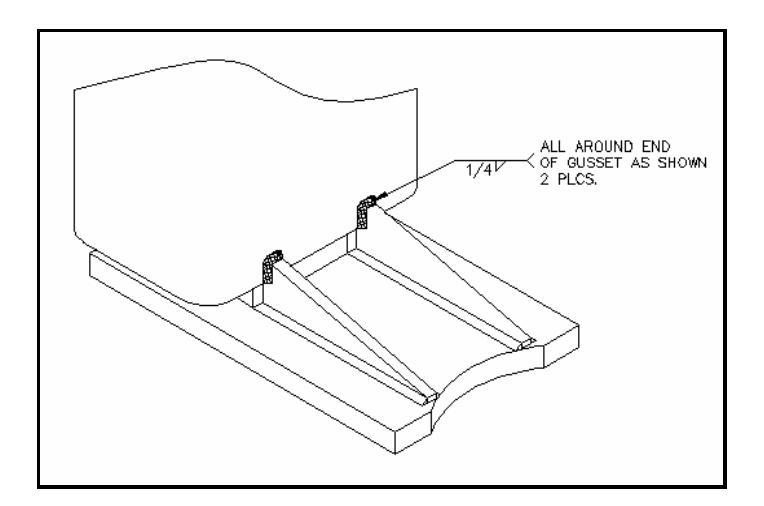
Figure 4: Gusset Weld

Cracks in the BUW Slide Gusset welds must be repaired as follows:

- 1. Remove the existing fillet weld around the top of the gussets (3) where they are attached to the lower end of the inner tube (4) using grinding or gouging method. It is essential that the cracks are completely removed.
- 2. Dry-MPI the crack area completely to ensure that the crack is completely removed.
- 3. Make a ¼" fillet weld around the top end of each gusset where it attaches to the end of the inner tube as shown in figure 4. Use Low Hydrogen E7018-3/32" or E7018-1/8" welding rods or equivalent (see Notes).

4. Dry-MPI the weld to ensure that there are no cracks in the weld.

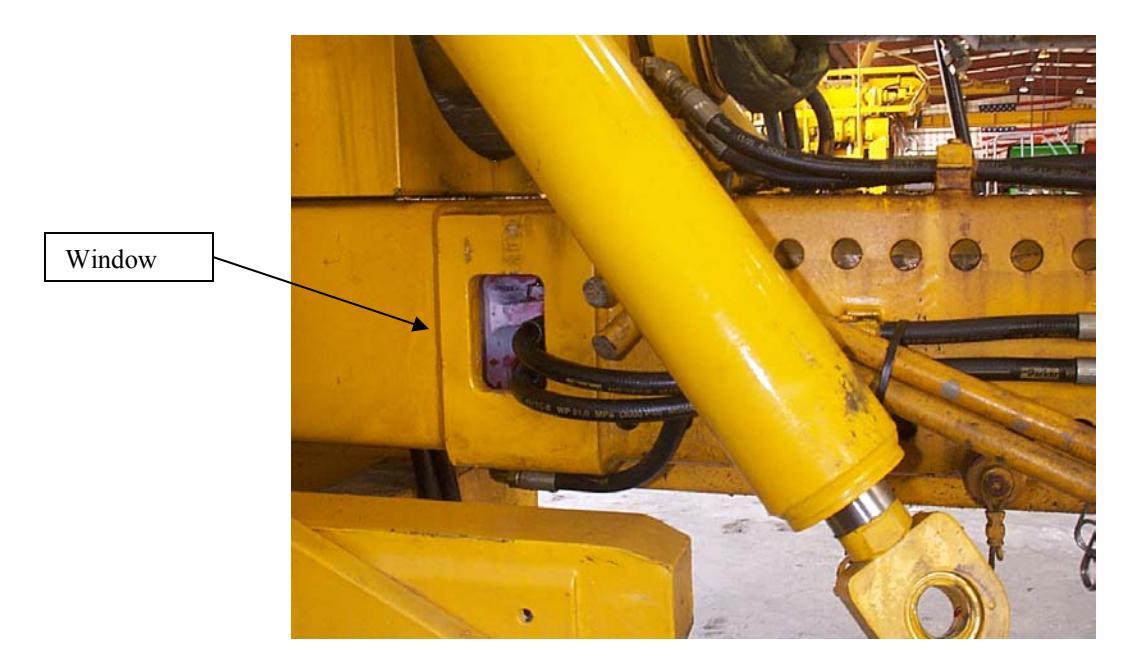
Figure 1

SUBJECT: Back-up Wrench – Outer Tube cylinder lug SERIAL NUMBERS: 002 and up DISCUSSION: An incident occurred where the weld joining the BUW positioning cylinder top lug to the BUW outer tube top mounting plate (see figure 1 and 2 of the attached inspection procedure) broke. This allowed the BUW inner tube to separate from the BUW outer tube. Upon investigation and in-depth failure analysis, it was concluded that the failure was caused by poor workmanship by a vendor. **RECOMMENDATION:** Inspect all BUW outer tubes for the condition of the welds holding the Lug in place. Attached is a suggested Top Lug Weld Inspection procedure. Should defects or indications be found, repairs may be performed in accordance with the attached repair procedure or contact CANRIG for further actions.

1. Disconnect the two hoses that are connected to the BUW cylinder through the driller side's small window in the outer tube as shown in figure 1 below. Due to the limited access, the use of Crow Foot Wrench to disconnect the hoses may be necessary.

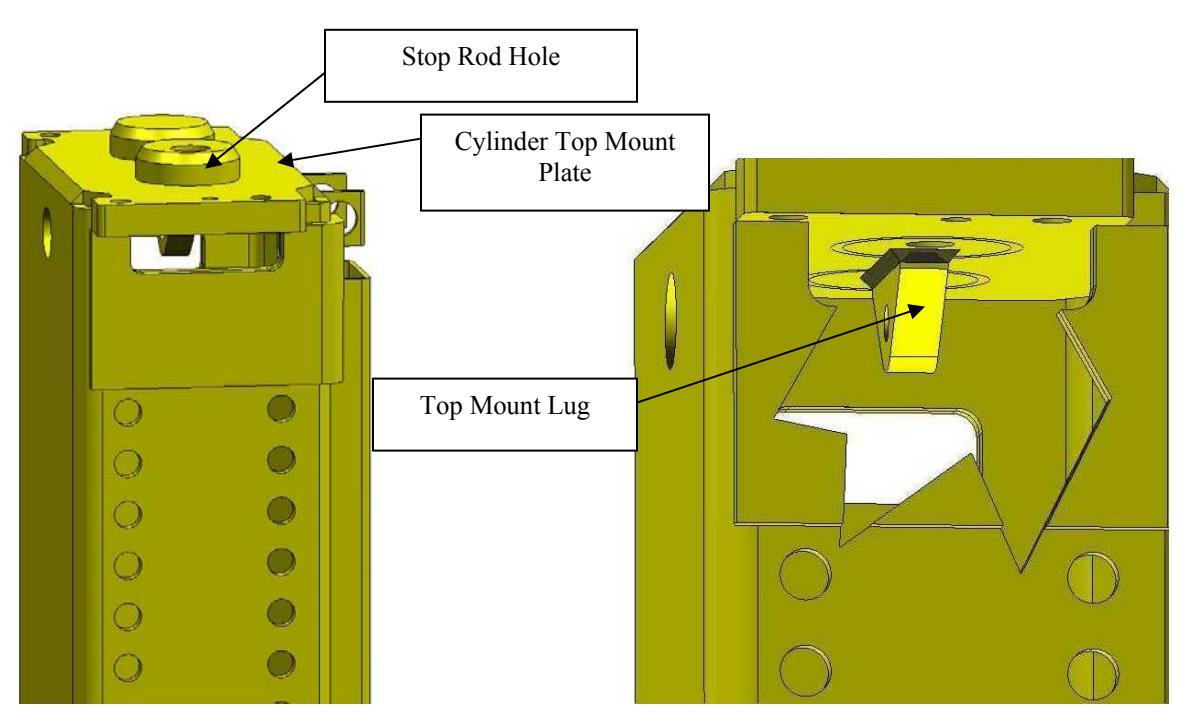
Figure 1: Short Outer Tube - Top Mount Lug

This procedure covers the repair of the lug on the BUW top mount plate. There are two different designs as to the location of this lug. In the short BUW, the lug is welded directly to the cylinder top mount plate of the outer tube as shown in figure 1. In the long BUW, the lug is welded to the cylinder top mount plate inside the outer tube as shown in figure 5.

- a) Torch cut/Air arc the welds that are connecting the cylinder top mounting plate to the outer tube. Be extremely careful not to expose the outer tube to too much heat.
- b) Remove the cylinder top mount plate and grind/smoothen the torch-cut edges.
- c) Torch cut/Air arc the welds around the lug. Grind excess weld on the cylinder top mount plate.
- d) Torch-cut/grind a $\frac{1}{4}$ " bevel around the base of the lug as shown in figure 2 below.

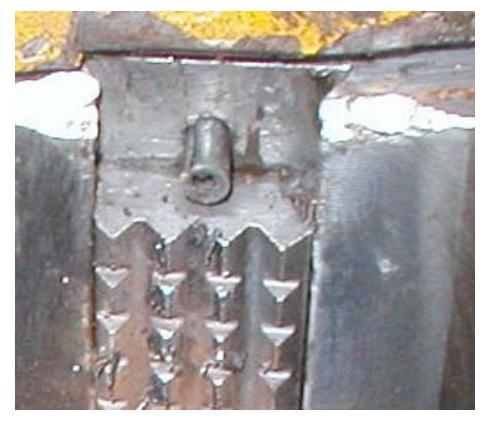
SUBJECT:	Top Drive Backup Wrench Die Retention		
SERIAL NUMBERS:	All		
DISCUSSION:	An incident happened recently where a die fell out of a top drive backup wrench to the rig floor. It is possible that the die is pushed up or down by pipe movement. Force is placed on the die retainers when relative movement takes place before the hydraulics have time to open or fully close the gripper. During this period the die teeth are biting the pipe but the large friction force between die and holder is absent. This allows the die to slide in the die holder and put a shearing force on the retainer. Dies are currently retained by cotter keys. The "HOLD CLOSE" feature should be eliminated because it has allowed the wrench to remain closed when the top drive was moved. It adds to the above issue due to release time of the hydraulics being slower than the instantaneous electrical release.		
RECOMMENDATION

Replace the cotter pin holding the die into the die block with a roll pin (slotted type spring pin). Canrig part # M17-1014-010 which is a 7/32 inch diameter x 1 inch long slotted type spring pin. This pin has much higher shear strength. Local sources are available.

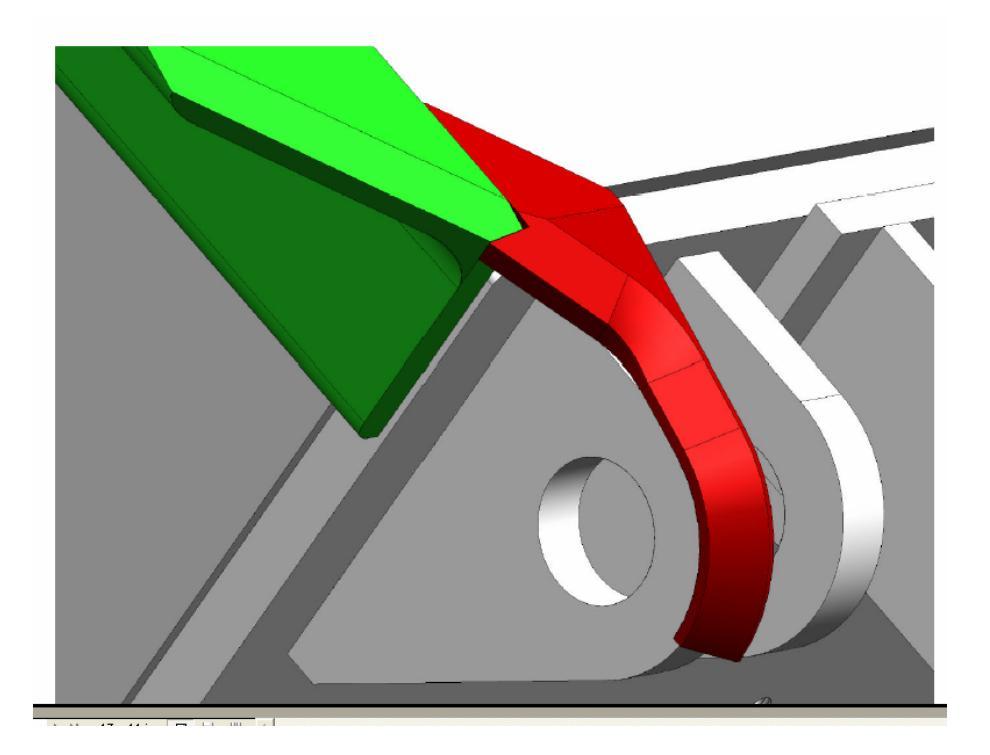
DISCUSSION: A near miss incident was reported, when a joint of casing got caught on an edge of the bottom of section 2 and subsequently fell to the floor due to breakage of the lifting sling. Although this was considered an unusual accident, CANRIG has developed an additional guard to the hinge point on the bottom of section 2.

RECOMMENDATION: *Perform the modification recommended in PB 52 (Shown Below)* Further, CANRIG has developed an additional guard that can be installed at the joint of section 2 to decrease another possible pinch point as per the attached drawings. Please order DT14141 and weld as shown on the drawing.
