TOP DRIVE PRODUCT BULLETINS ARIG (Δ DRILLING TECHNOLOGY LTD.

CANRIG TD PRODUCT BULLETIN MANUAL

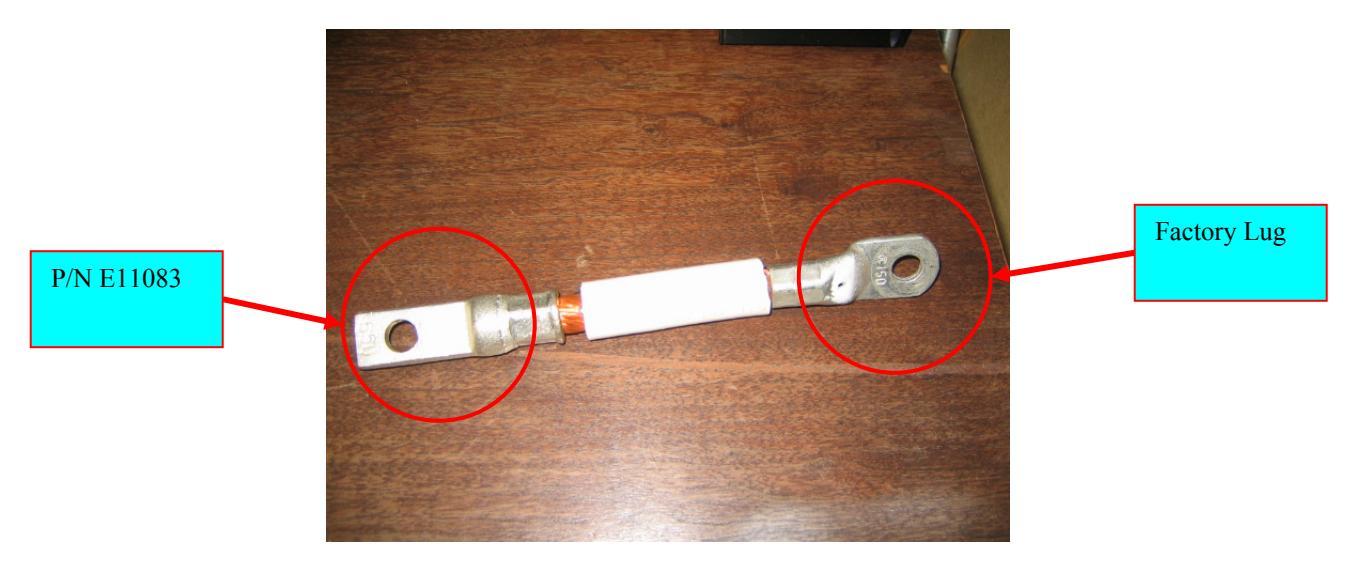
Step 1. There are ONLY 2 properly suited lugs for the WEG AC motor as shown in FIGURE A.

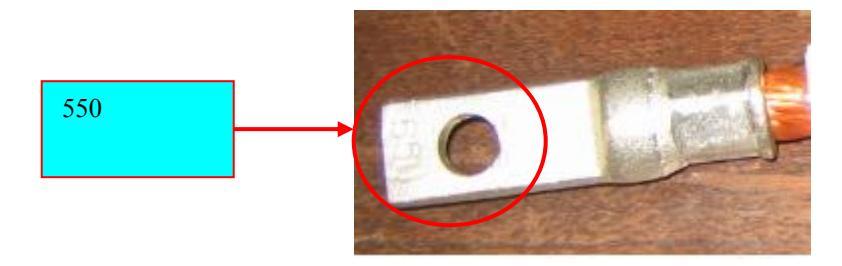
Step 2. For the non-factory lug, a quick way of identifying the correct lug is to check the inscription on the back; it should have 550 stamped on the back. FIGURE B Note: This may or may not require the de-lugging and re-lugging process.

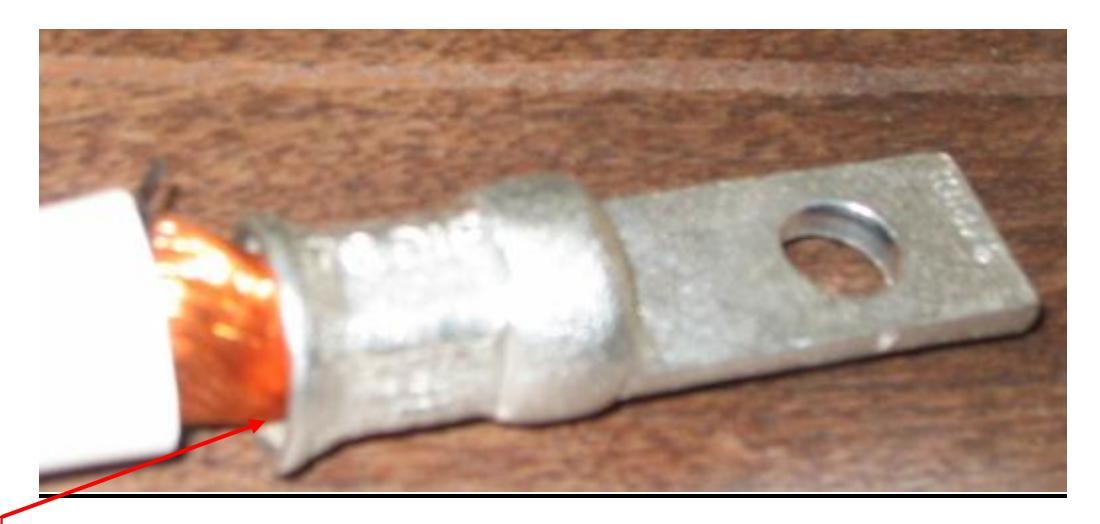
FIGURE C.

- Step 3. An easy way of identifying the incorrect lug is as follow:
 1. Check the stamp on back of the lug; it should have 775 stamped on the back.
 2. If the wrong lug has been installed, a gap is visible. See FIGURE C

Air Gap

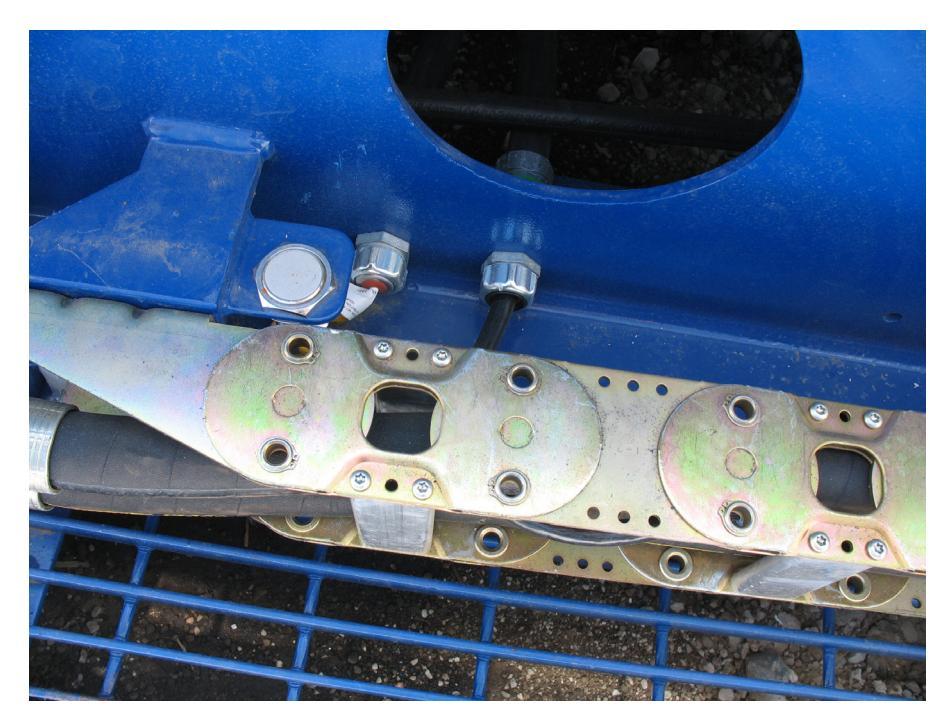
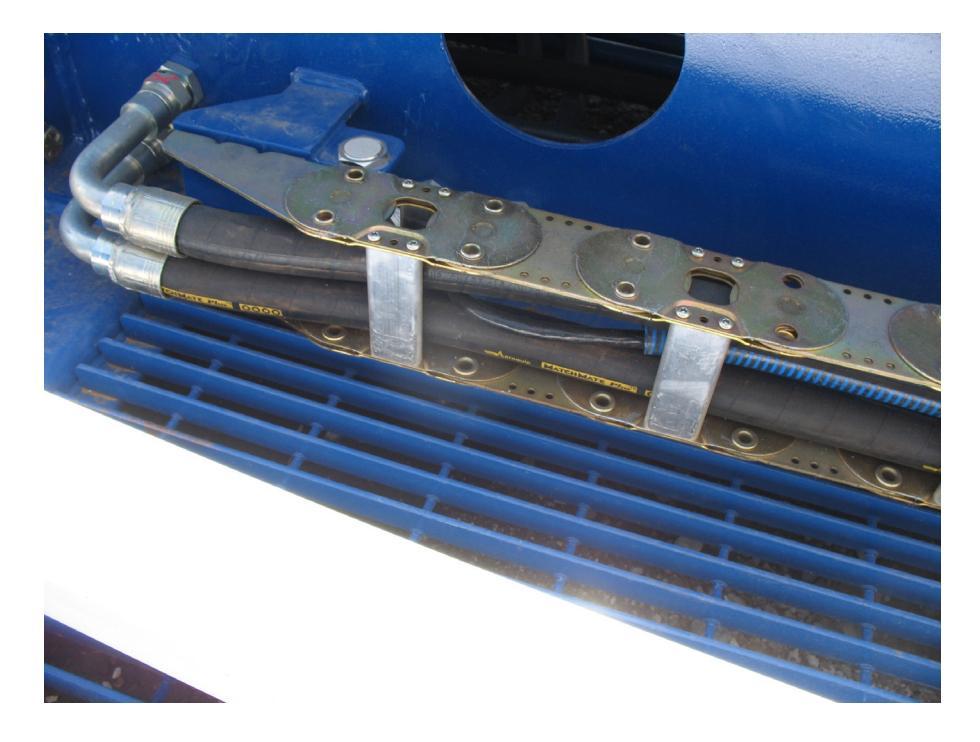
Check the cable at each aluminum bar for signs of wear or bared wires. This is most likely where the cable is to wear.

The service loop wiring should be inspected immediately for any signs of wearing or bared wires throughout the length of the service loop cable from the catwalk base bulkhead, thru the drag chain, spear, lift arm and into the carrier junction box. If there is any indication of wearing or tearing of the cable sheath or bared exposed wires anywhere in the service loop cable, call Canrig service immediately to have a service technician repair or replace the cable. **Do not operate the Power Catwalk until this cable is repaired.**

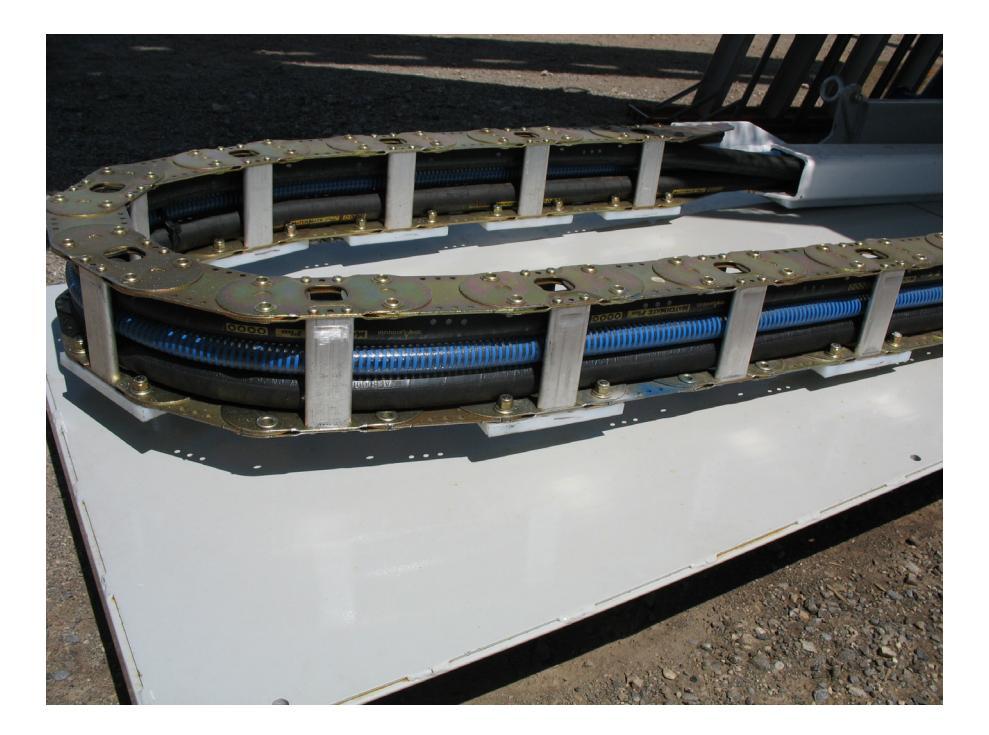
Check cable where it enters and exits the spear and enters the lift arm.

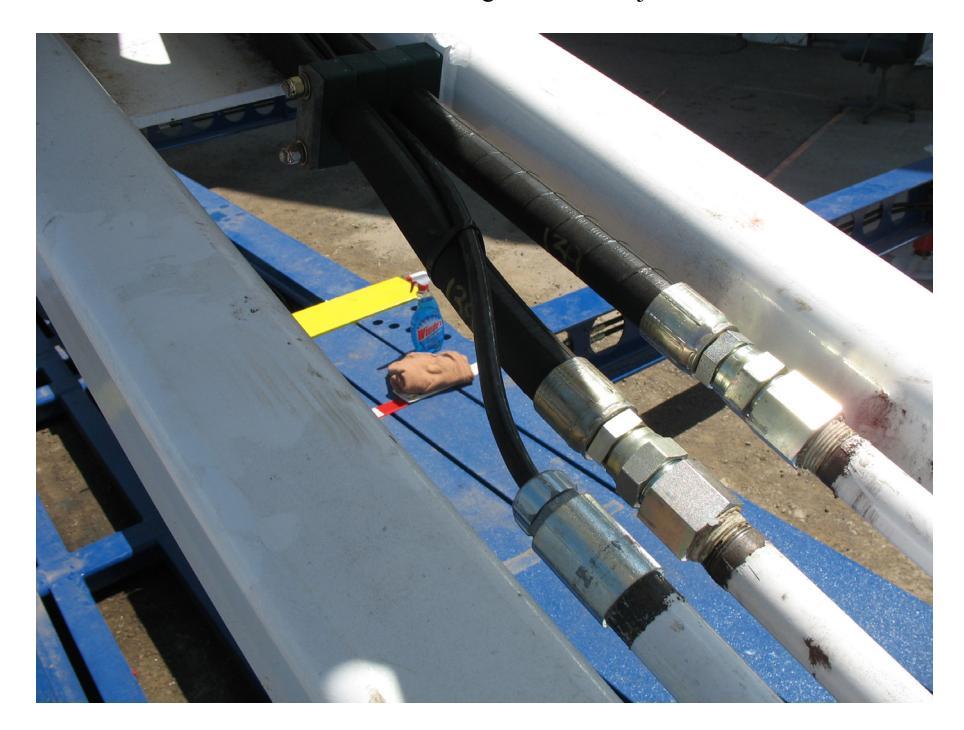
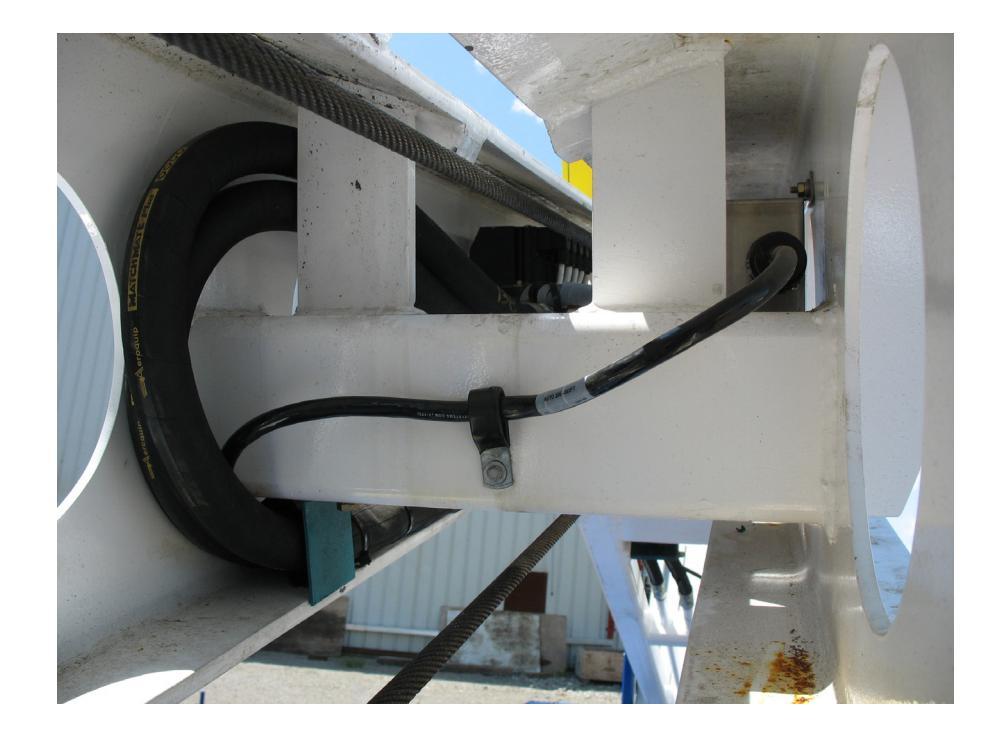
Check cable where it exits the Lift Arm right thru to the junction box in the Carrier.

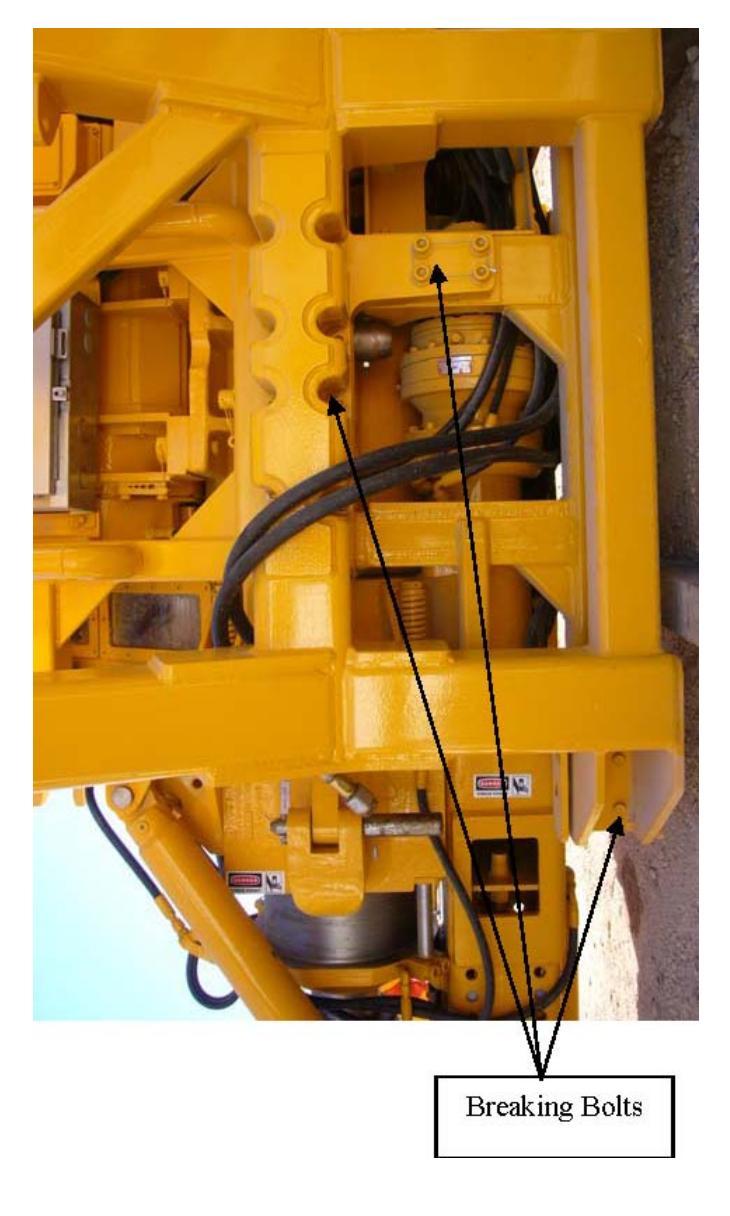
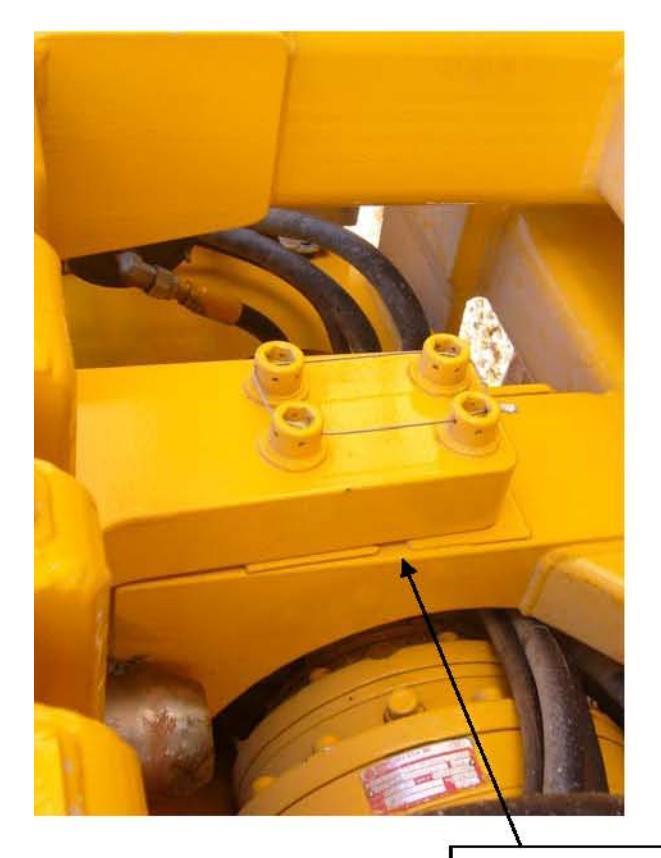
DISCUSSION: There has been an incident where the bolts attaching the Guide Runner Frame to the Main Housing have been breaking. Examination has revealed that when the Guide Runner Frame is made up correctly against the Main Housing, it may not be made up flush against the legs of the Frame Base; thus gaps are noticed as seen in the pictures bellow. When the mating surfaces are not made up correctly against each other, the bolts may not share the load equally and the potential for the bolts to fail prematurely exists.

Gap between Frame Base Legs and Guide Runner Frame

Gap between the Frame Base and the Guide Runner Frame

To eliminate the bolt breakage, inspect, shim if necessary and replace flat washers with Nordlock washers as outlined in the procedure below:

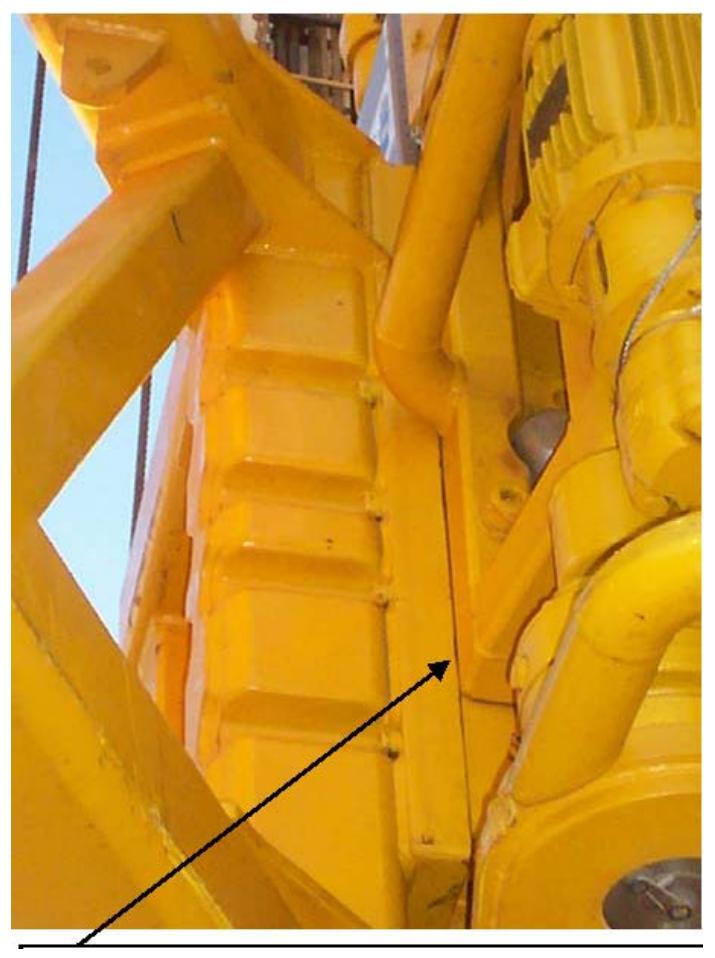
Possible gap between Main Housing and Guide Runner Frame

5 Start by adding shim between the housing and the Guide Runner Frame to take up any gap that was found between them in step 2. Replace the current washers with the Nordlock washers provided. Tighten these bolts to there recommended torques. 418 Ft-Lb for the ³/₄" bolts and 238 Ft-Lb for the 5/8" bolts. (Torque values shown have already been increased by 20%.)

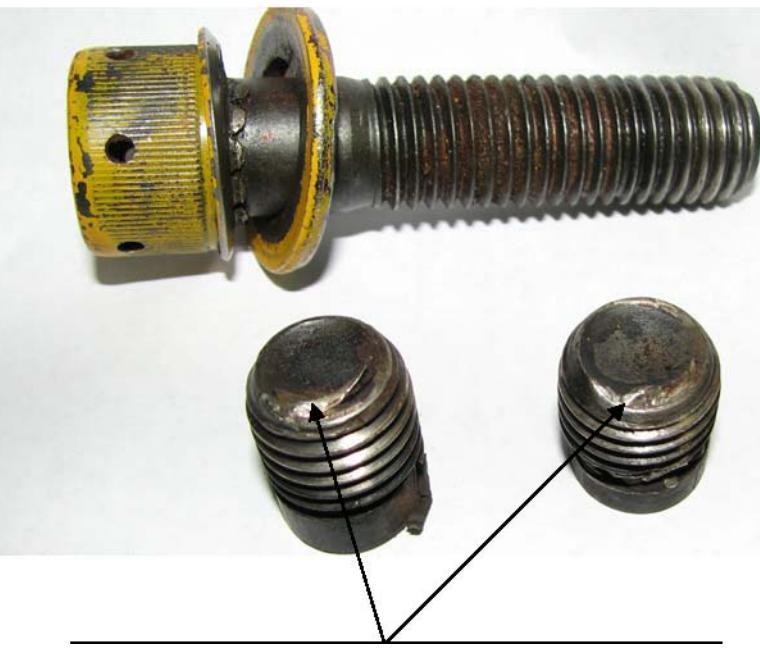
Returned bolts were examined and it was determined that some of the bolts have bottomed out in the hole rather than at the shoulder. This could have happened only if the threaded holes in the main housing and/or in the Frame Base Legs were tapped short or the bolts were too long.

Signs of bolts bottoming out in the tapped holes of the Main Housing and/or the Frame Base Legs

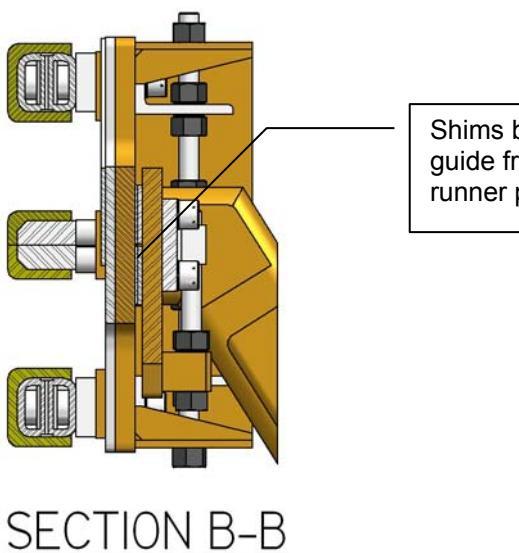
Shims between the guide frame and the runner plate.

4. The first place to check what you need is at the narrowest point of the mast. Subtract the outside to outside distance of the wear pads on the top drive from the narrowest inside to inside measurement on the guide rails. Subtract 1/8" from this number and this is how much shim will need to be added between items 11, 12 and item 03. The shims come in ½, ¼ and 1/8 widths. (See attached drawing AY13279)

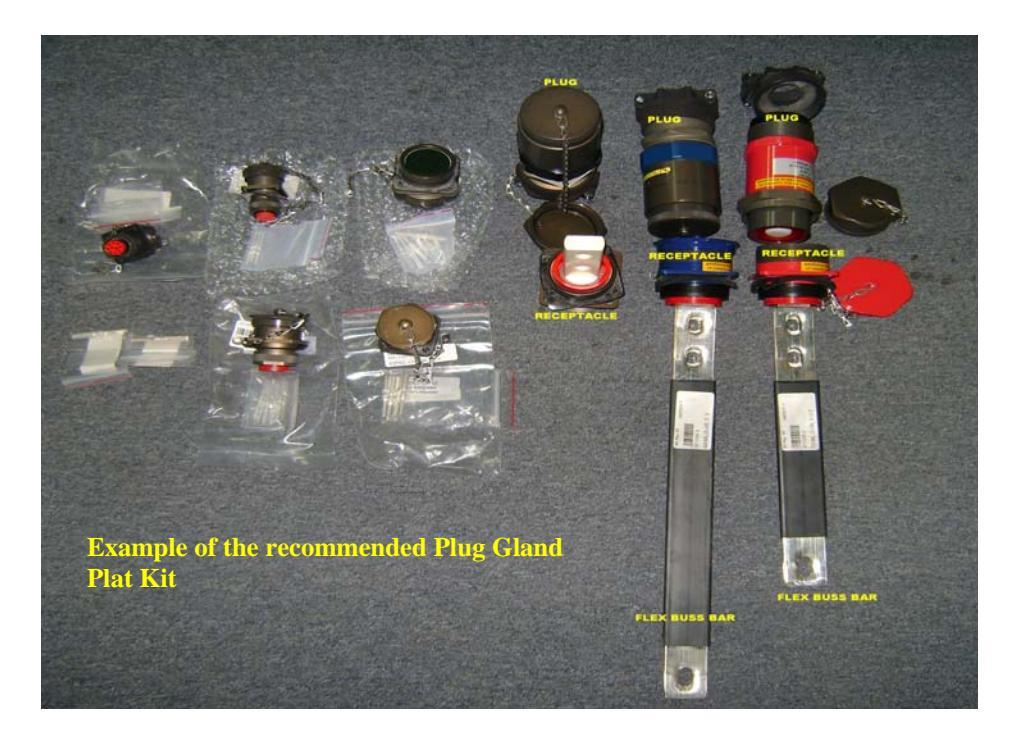
Figure 11

- On later model Top Drives the J-Box are equipped with Gland Plates (see Figures 11 & 13); Canrig recommends the purchase of a Plug Gland Plate Kit. This kit will substantially improve the Torque Guide J-Box (if applicable) in the following ways:
 - 1. Reduce Rig-up and Rig-down Time
 - 2. Eliminate the need of opening the Torque Guide J-Box.
 - 3. Prevent water from leaking into J-box during pressure washing.
 - 4. Reduce the amount of time required to connect motor leads and insuring proper connection.
- 11. Not all lower torque guide J-Box are built or wired the same. It is very important when calling Canrig Service to provide the following information to correctly identify the Plug Gland Plate kit.
 - 1. Top Drive Serial number
 - 2. Verify that the lower torque guide J-Box <u>does have</u> a gland plate that is bolted to the J-Box (see Figure 13): <u>YES</u> or <u>NO</u>

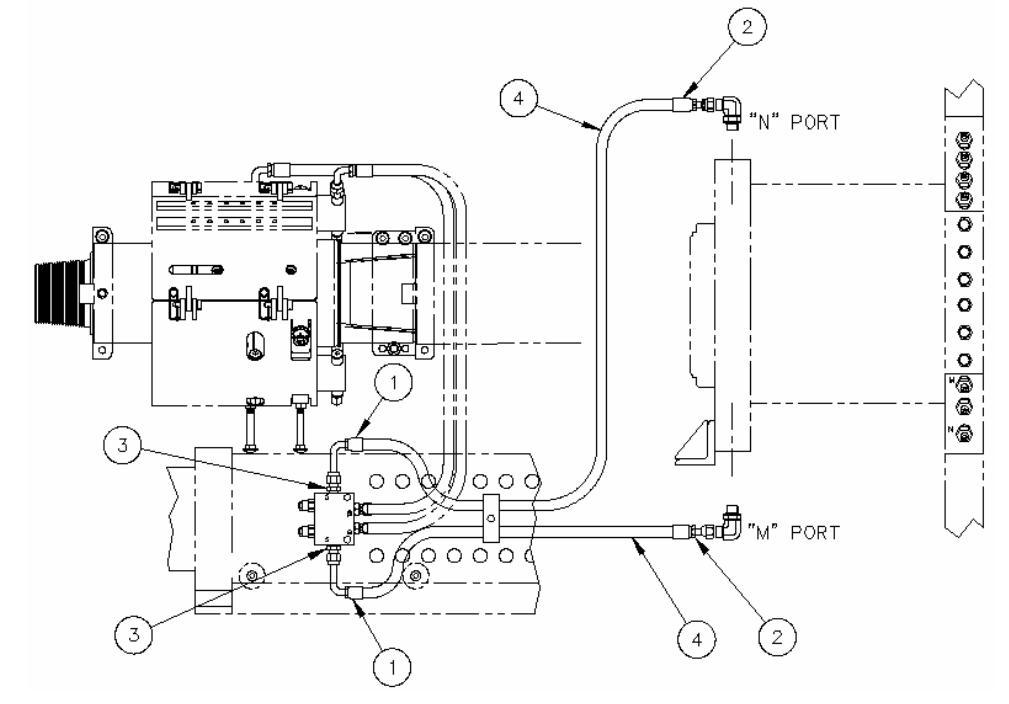
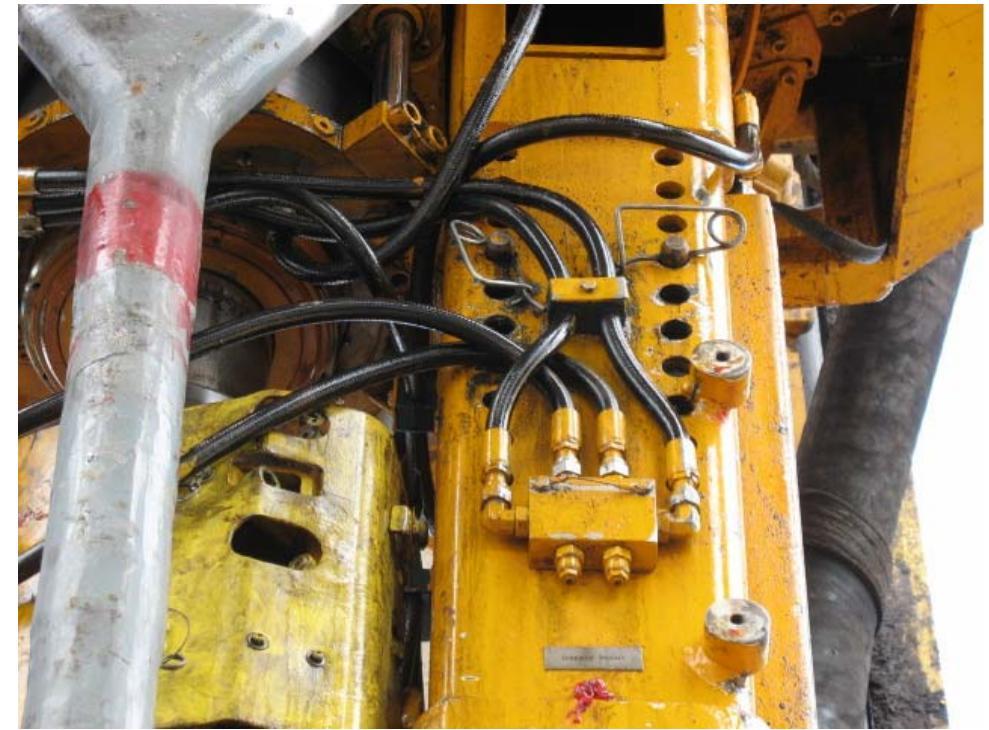
BEFORE

PRODUCT: Top Drive	DATE: March 01, 2010			
SUBJECT:	BUW Stop Pin Interference/ Actuator Fittings			
SERIAL NUMBERS:	Up to S/N 761 with Canrig Lower Well Control Valve Actuator			
DISCUSSION:	The existing 90 degree fittings on the Lower Well Control Valve Actuator manifold on the outer tube of the Back-up Wrench do not allow for access to the lowest two Backup Wrench positioning holes.			
RECOMMENDATION:	If it is required to use the stops in the lowest positions, the existing 90 degree fittings should be replaced by straight fittings and long 90 degree fittings so that the hoses will clear the Backup Wrench positioning holes. This requires a new hose assembly to be used.			
	In order to complete the retrofit, the kit needed is:			
	1 EA – AY15600 – KIT, UPGRADE, HOSE, LWCV INTERFACE			
	The retrofit kit consists of these parts: 2 EA - H15-3010-08-08 - HOSE FTG,ELL 90°LG, 1/2,FEM SWV 1/2 ORFS 2 EA - H15-3007-08-08 - HOSE FTG, STR, 1/2, FEM SWV 1/2 ORFS 2 EA - H15-520120-08-08 - ADAPTER, MALE 1/2 ORFS, MALE 1/2 ORB 10 FT - H16-1381-08 - HOSE, HP SAE 100R2, 1/2, 4250 psi

Remove the pre-existing hose assemblies and 90 degree fittings. This may require the loosening of the counterbalance valve to allow clearance. Cut item 4 (hose) to required lengths in order to clear the BUW pins and attach items 1 and 2 (field attachable fittings.) Thread Item 3 (adapter) into the V1 and V1 ports in the manifold then reconnect the hose assemblies at previously designated locations.

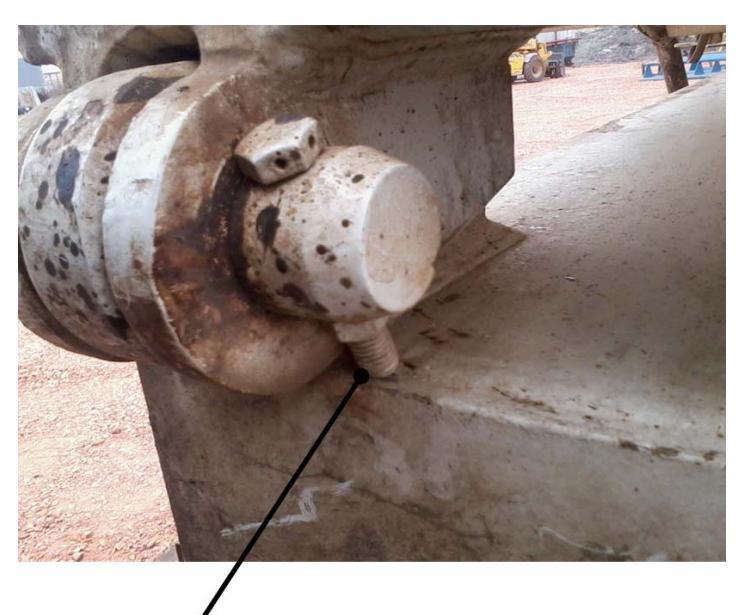
FIGURE 1

The retaining bolt on the torque guide pivot pin may catch on the edge of the torque guide as shown in FIGURE 1. If there is interference between the bolt and torque guide during the operation of raising and lowering of the torque guide, the reacting forces may cause the bolt to shear.

BOLT/TORQUE GUIDE

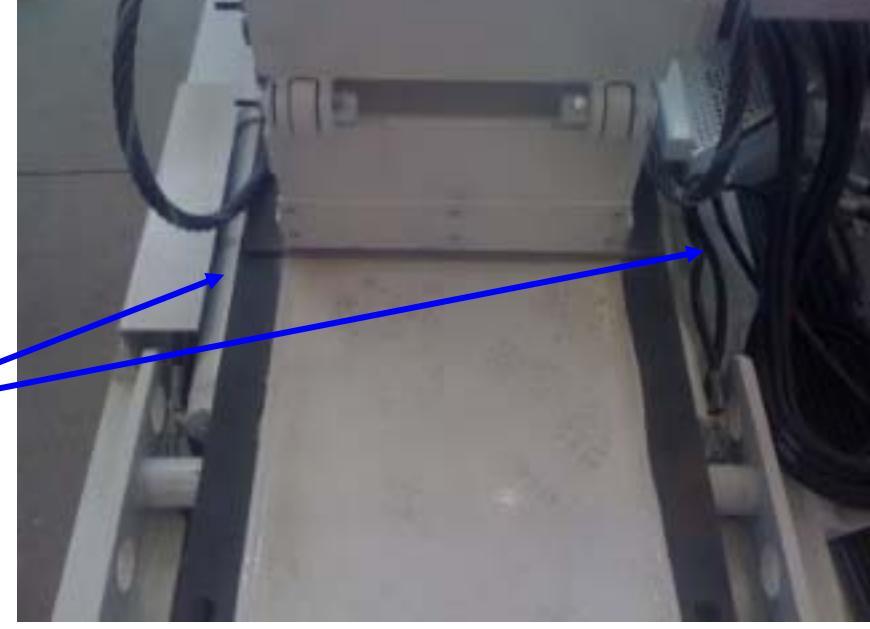
FIG. 1

SUBJECT:	Torque Guide Section 1, Tensioning cylinders guard	
SERIAL NUMBERS:	N/A	
DISCUSSION:	A Guard around the Tensioning cylinders on the Torque Guide, Section 1, was only tack welded and this was missed on inspection. The tack welds subsequently failed, in the field, and the guard fell to the rig floor.

Location of Cylinder Guards Under Tensioning Cylinders

- 1. If there are insufficient welds, or only tack welds. Properly secure the plate to insure it does not fall to the rig floor until Repairs can be performed.
- 2. If welding is required, insure all equipment is turned off, and the ground for welding is located on the Torque Guide and as close to the welded area as possible.
- 3. Repairs can be performed using good welding practices for mild carbon steel.

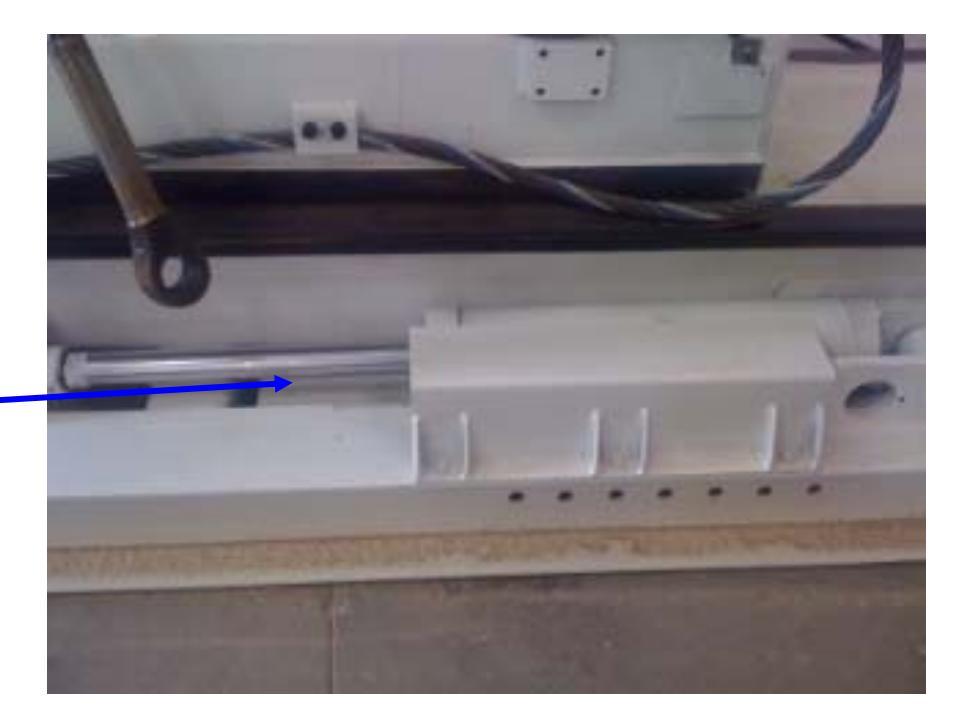
FIG.2

Top View Of Cylinder Guard

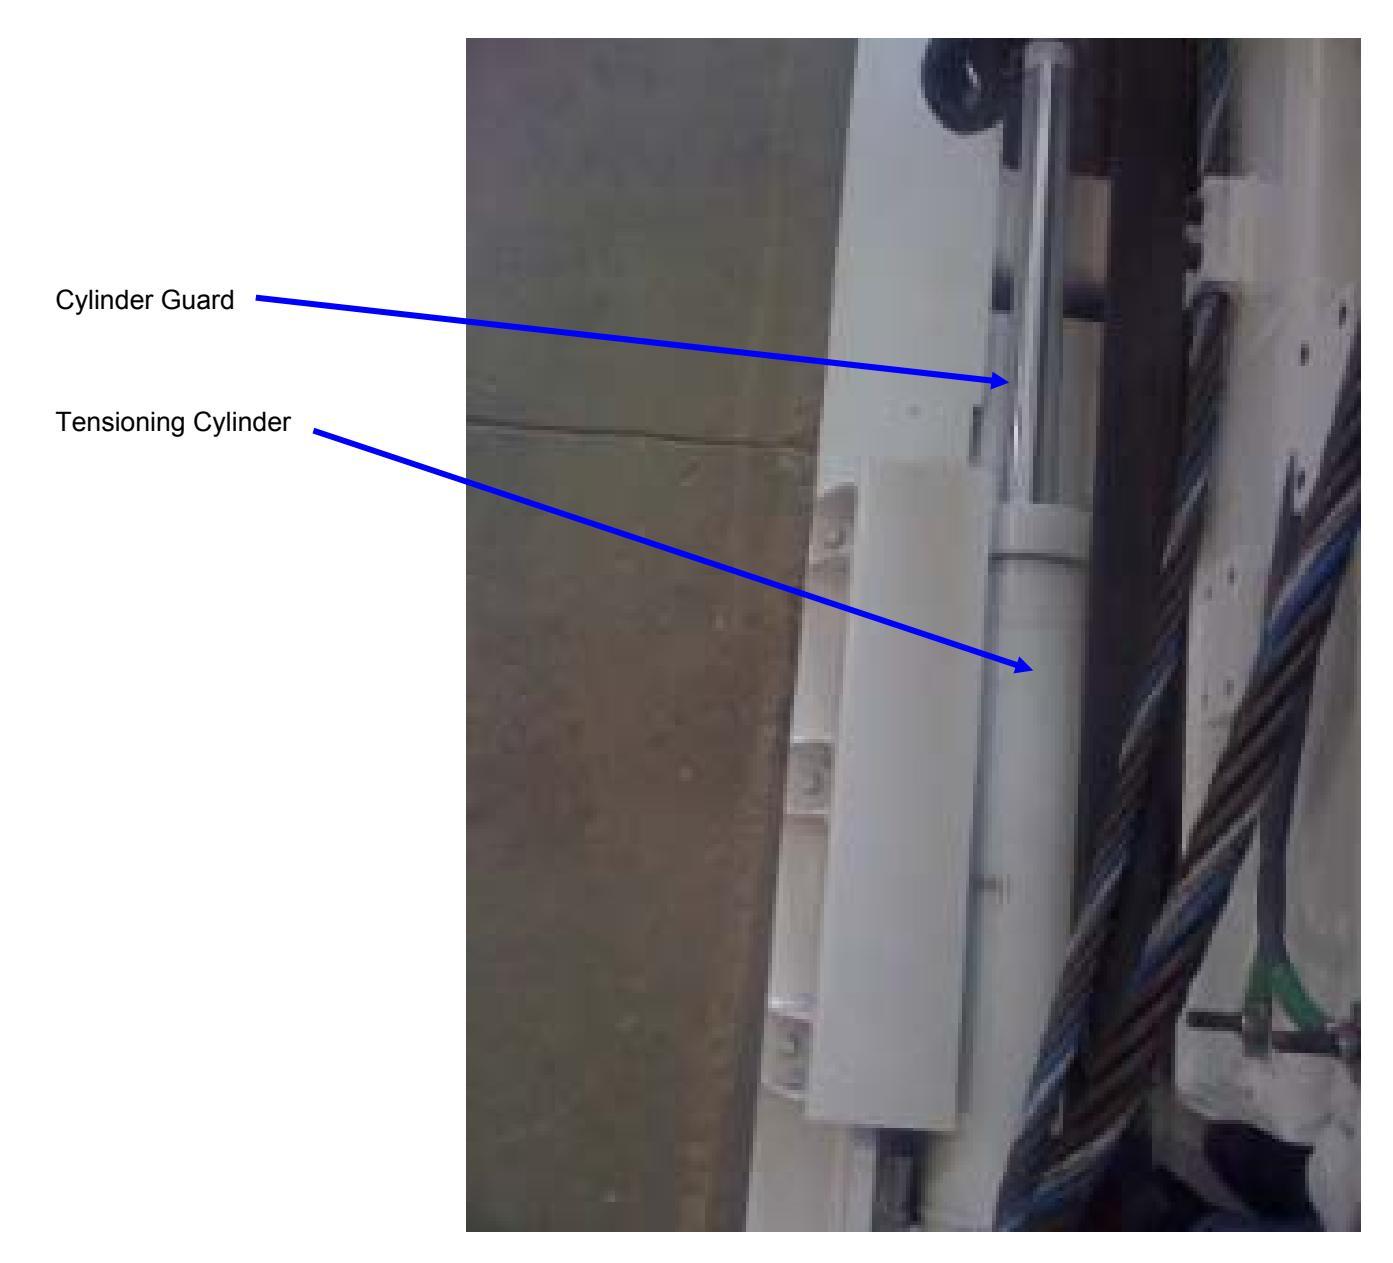
FIG. 3

See Fig 4, 5, & 6 for welding inspection areas

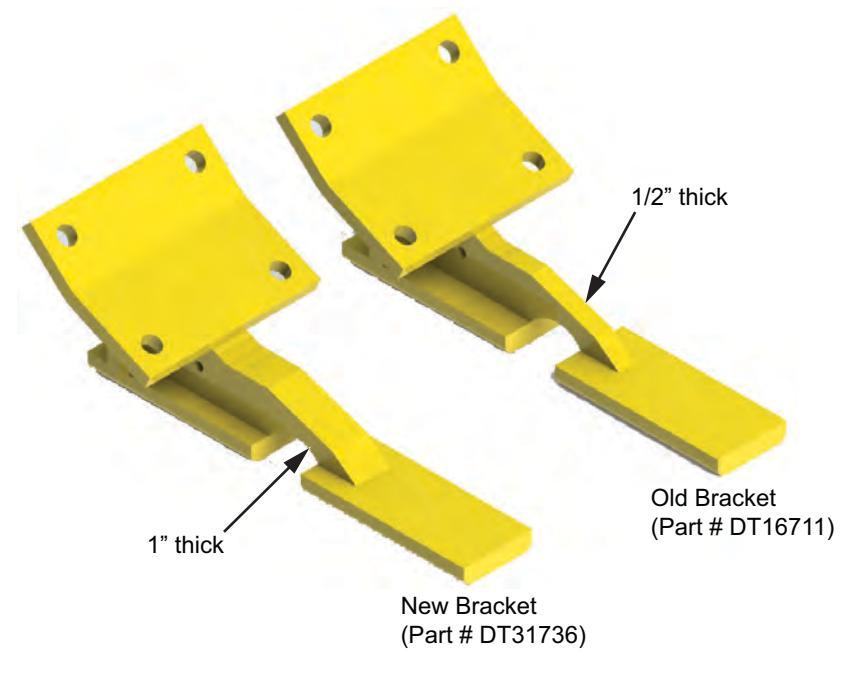
Figure 2: Old and New LWCV Anti-Rotation Brackets

Figure 1 on page 2 shows a crack on the old anti-rotation bracket (Part # DT16711). This bracket is 1/2" thick. The replacement bracket (Canrig Part # DT31736) is made using 1" thick plate and uses stronger material. (See Figure 2 on page 2.) This replacement bracket may be ordered from the Canrig Sales department.

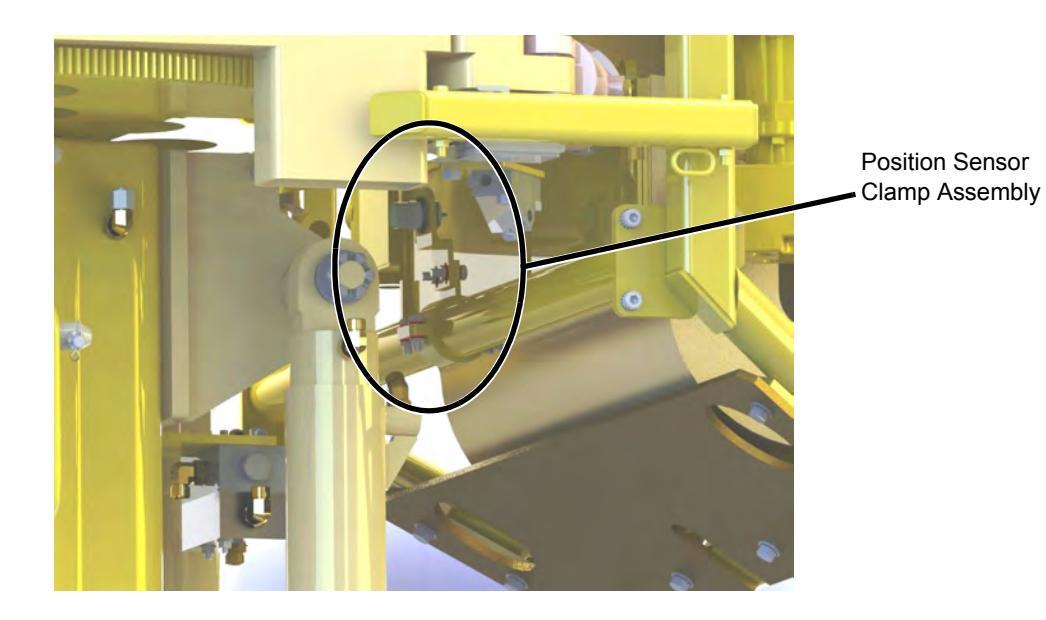
The new position sensor clamp assembly may be installed to eliminate any possibility of interference. Refer to Figure 1 below for an example of a mounted top drive position sensor.

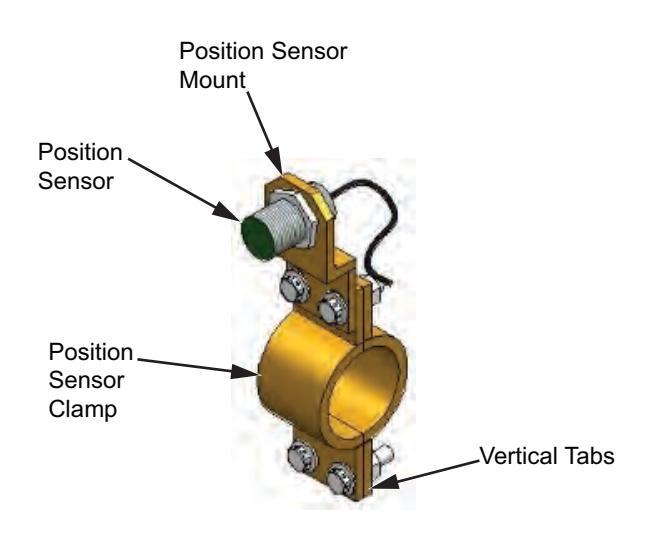
Figure 2: Old Assembly (Canrig Part # AY12991 & AY12991-1)

The elevator alarm position sensor clamp assembly on 500T/650T/750T AC top drives could possibly interfere with the hydraulic fittings on the link tilt cylinders when they are fully retracted and the pipe handler is rotated. While the practice of fully retracting the link tilt cylinders when the handler gear is rotated is not recommended by Canrig, the position sensor clamp assembly has been redesigned to prevent this interference from occurring.
