# TORQ-MATIC WRENCH PRODUCT BULLETINS

**CANRIG PRODUCT BULLETIN MANUAL**

Product Bulletin #	Subject	Page
Wrench 001	Leaking Fittings within the hydraulic valve Banks	5
Wrench 002	Cylinder Gusset Failure on Main Boom	6
Wrench 003	Orientation of spinner roller seals	7
Wrench 004	Shearing Belleville Stack Mounting Studs	10
Wrench 005	Inspection of Main Boom Pin Tube and Support Gussets	15
Wrench 006	High Pressure Control Seats for Hydraulic Valve	24
Wrench 007	Inspection of Vertical Lift Channel	27
Wrench 008	Tong Cylinder Orifice	27
Wrench 009	37-Pin Cable and Receptacle Cap Plugs Getting Pinched	30
Wrench 010	Cable Guide / Encoder Guard	33
Wrench 011	Locking Joystick on Driller's Console	37
Wrench 012	Sealed Electric Operator for Horizontal Extend/Retract Valve	42
Wrench 013	Tong Cyliner Upgrade	56
Wrench 014	Wrench Lifting Procedure	61

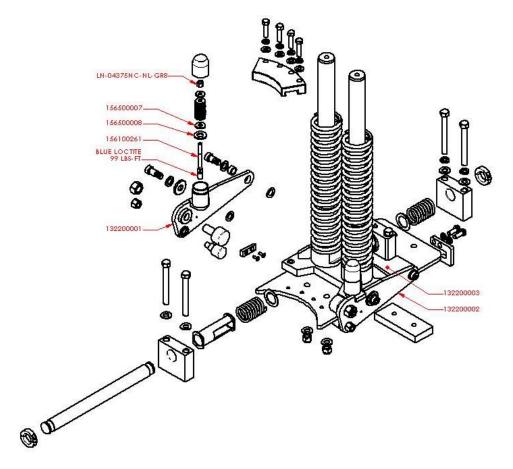
**RECOMMENDATION:** It has been determined that there is a possibility the Belleville Mounting Studs on

the Jeep Assembly will shear. If this happens, the Spinner/Jeep Assembly will lean at an angle towards well center rather than vertical. Clamping onto drill string in this position will cause the Spinner/Jeep Assembly to violently snap into position, causing damage to the Jeep Assembly, Link Arms and Jeep Rear

The "Frame, Jeep Carriage, TM-80", left and right "Side Arm, Spinner Track Jeep", "Stud, Mounting, Belleville Washer Stack" are modified designs that need to replace the old parts. Also, there are 2 washers made from UHMW that need to be installed under the Belleville Stack to allow free movement of the assembly.

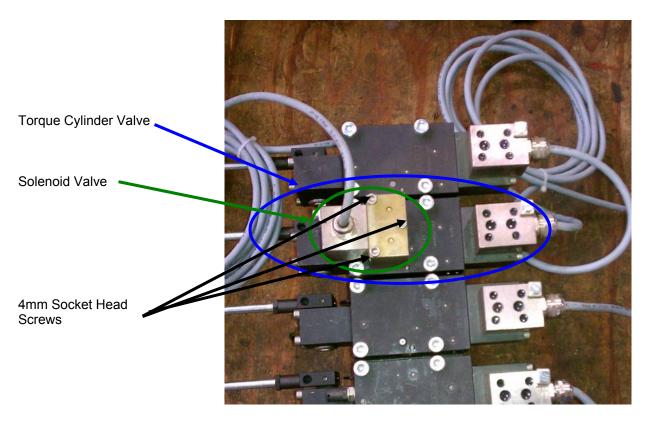
Figure 1: TM-80 Tong Valve Bank

Hydraulic control valves for Torq-Matic wrenches have been installed by Canrig with pressure control seats on the torque cylinder valve rated for 320 bar (4641 psi). However, the wrench torque cylinder may operate at hydraulic pressures up to 355 bar (5150 psi). At higher operating pressures, the pressure control cones (darts) have a tendency to stick and cause the valve to malfunction.

4. Remove the solenoid valve from the tong cylinder valve by loosening the 4mm socket head screws (see Figure 1) with a socket head wrench.

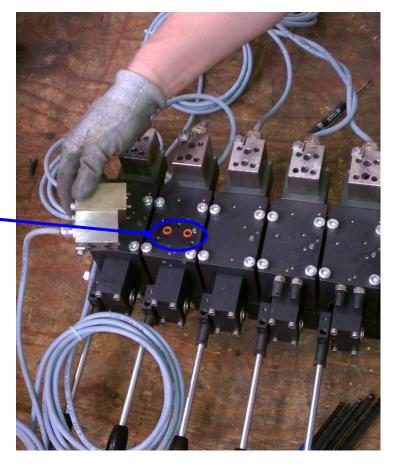
Figure 2

Pressure Control Cones, Seats, & O-Ring Seals

5. Remove pressure control cone, seat, & o-ring seals from both ports using magnetized screwdriver and pick (or needle nose pliers).

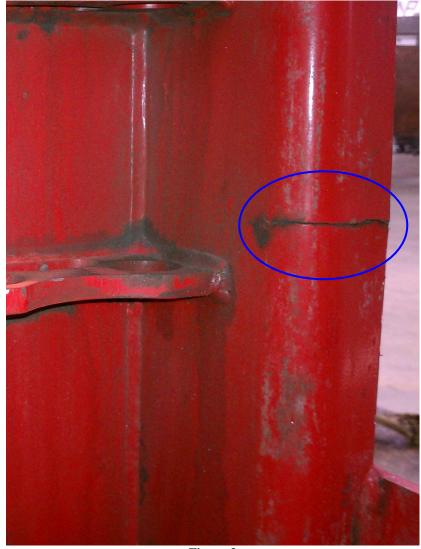
Figure 3

In a few isolated instances, rig crews have discovered cracks in the Vertical Lift Channel located approximately one third to halfway from the base of the channel. Probable cause of these cracks is most likely a result of repeated excessive loading or a singularly large impact load beyond normal operation of the wrench.

- Remove any valve hand controls if installed.
- g. Inspect the bottom half of the Vertical Lift Channel for any signs of cracks. Clean the area in the channels for greater visibility if necessary.
- 2. If you find evidence of cracking, as shown in Figure 3, contact the Canrig Service Support Department immediately for an assessment. Contact information is provided below.

3. Failure to identify the problem and have it promptly corrected could potentially damage the equipment and, if not dealt with, could potentially become a hazard to personnel.

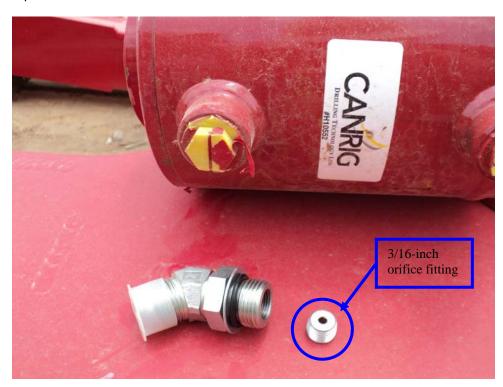
connector fitting (45 Deg or straight fitting). It is imperative to have this orifice in place; this allows a smoother and more accurate operation of the tong clamps. There is potential for the orifice in the fitting to not be installed when fitting is

replaced.

Ensure that the 3/16" orifice is being replaced when a replacement fitting is installed on the rod-side. The orifice is essential for reducing flow so that the cylinder retracts smoothly.

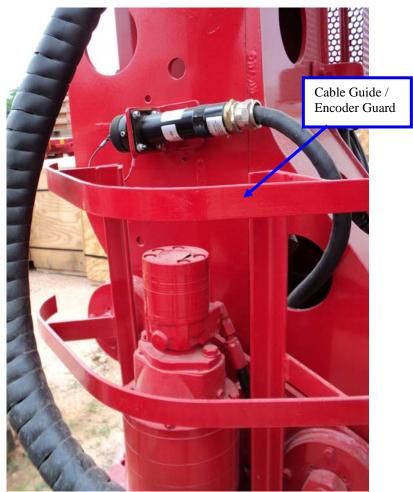
Figure 2: TM-80 Wrench with Cable Guide/Encoder Guard Installed

Hoses/cables can get caught on motor (shown) or encoder (not show).

Installing the Encoder Guard will help prevent cables and hoses from catching on the motor or encoder as well as providing added protection during standard rig operations. See Figure 2.

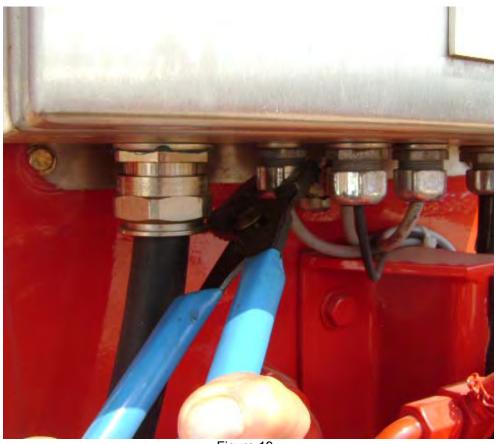
Figure 19

19. Route the new coil cable back through the strain relief and into the arm junction box. Tighten the strain relief once the cable has been passed through, leaving some slack behind to avoid having the cable stretched out from the coil to the junction box (Figure 19).

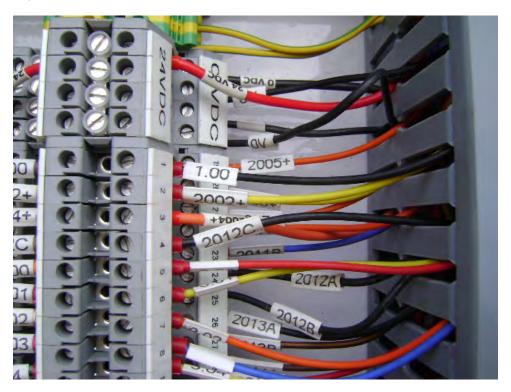
20. Terminate the coil wires back to their proper locations (as removed) (Figure 20).

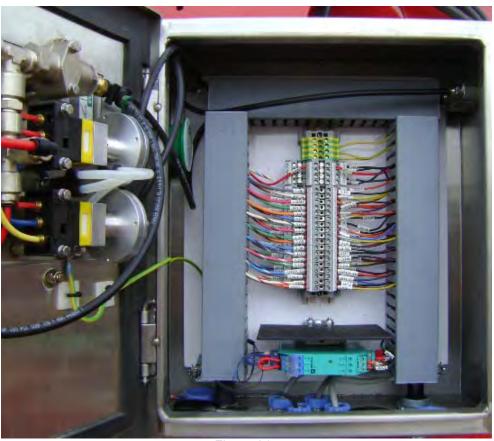
Figure 21

21. Reinstall the wire cover and close the arm junction box (Figure 21).

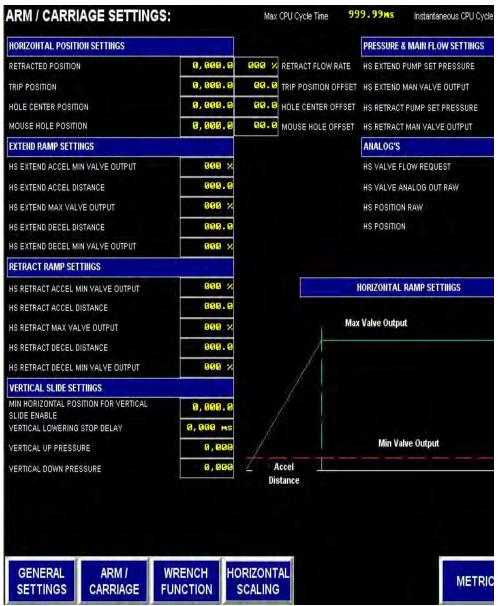
Figure 22

- 23. Recalibrate the 2012 PR card
  - a. Change LOA setting from 20 to 25.
  - b. Change IA2 setting from 57 down to 52.
  - c. Change LOB setting from 20 to 25.
  - d. Change IB2 setting from 57 down to 52.
- 24. Test the functionality of the new horizontal valve operator and adjust the speed set points, as necessary, located in the Advance Settings under the Arm/Carriage page on the HMI (Figure 22). Perform this operation for both the Extend and Retract function until the proper speed has been accomplished.

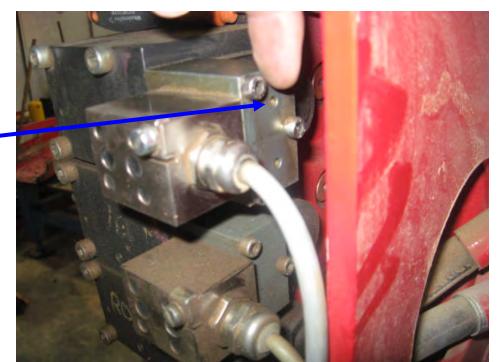
Figure 23

25. Once the automatic speed settings have been properly adjusted, manually extend and retract the tong assembly in the horizontal direction by pushing the top button on the electric operator to extend and the bottom button to retract (Figures 23 and 24).

PRESS TO EXTEND MANUALLY

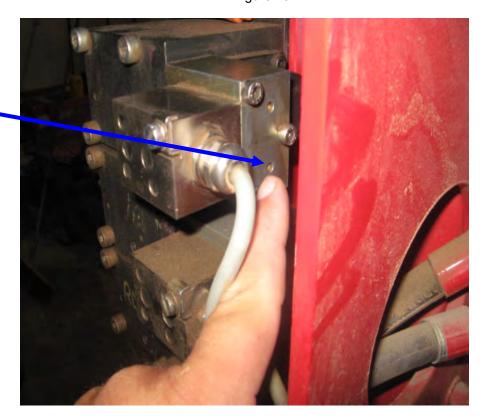
Figure 24

PRESS TO RETRACT MANUALLY

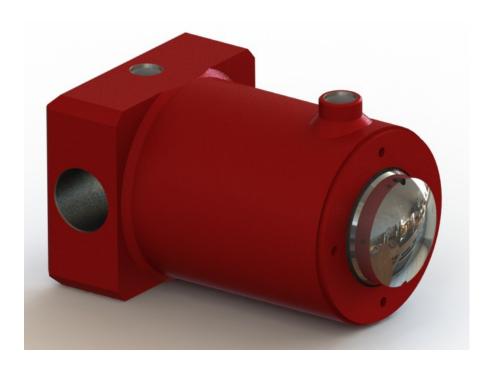
- 2. Addition of piston wear ring reduces frictional resistance and provides better seal between piston and barrel wall.
- 3. Relocated o-ring on cylinder head protects o-ring from damage and offers better leak prevention.
- 4. Internal orifice on rod end reduces part count and eliminates need for externally installed orifice.

The new cylinder results in a near doubling of the Factor of Safety relative to system hydraulic design pressure over the current cylinder.

**RECOMMENDATION:** The current cylinder (H10552) will be obsoleted once inventory is depleted.

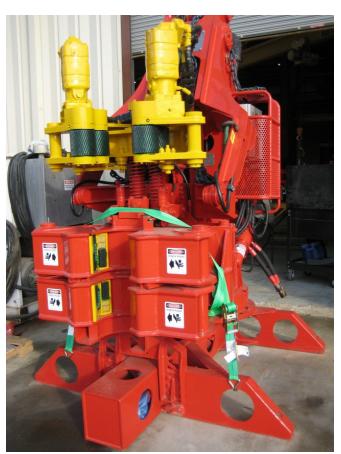
Figure 2

- 17. Insert the J-Hook of one end of the ratchet strap through the hole in the skid indicated in Figure 9. Loop the ratchet strap over the upper tong, travelling jeep frame, and opposite side of the upper tong (Figure 2). Insert the opposite end J-Hook into the opposite end skid hole and ratchet down the ratchet strap.

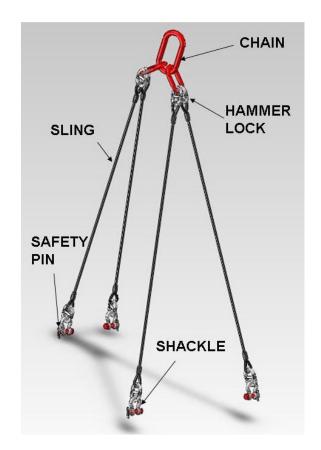
Figure 3

- 11. Install the safety pin through the hole in the screw pin (Figure 7).
- 12. Connect the shackles to the hammer locks attached to the sling.
- 13. Connect the hammer locks at the top ends of the two short slings to a common chain link. Connect the hammer locks at the top ends of two long slings to a common chain link. Connect the common chain links to the main chain link (Figure 3).

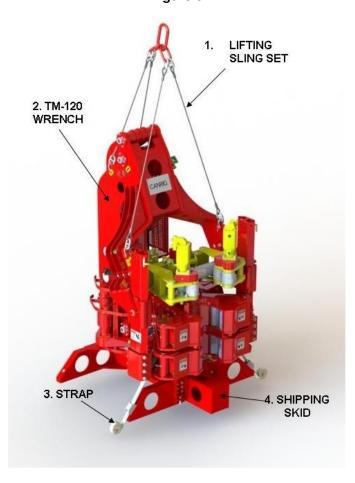
Figure 4

- 4. Inventory the transport items and make up any shortages (Figures 4). Transport items include:
  - a. Shipping Pins (DT50531 x 2).
  - b. Linch Pins (M24-5003-010 x 2).

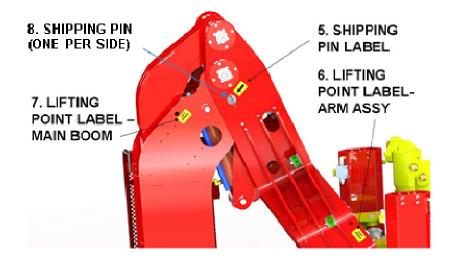
Figure 5

- 5. Insert the shipping pins on both sides of the wrench through the shipping pin holes in the main boom and jib boom (Figures 5 & 6).
- 6. Secure the shipping pin with the linch pins.

- 7. Match the appropriate sling length to the correct location (shorter slings to rear on main boom and longer slings to front on jib boom).
- 8. Install the four shackles through the lift holes identified by the lift point labels (Figure 5).

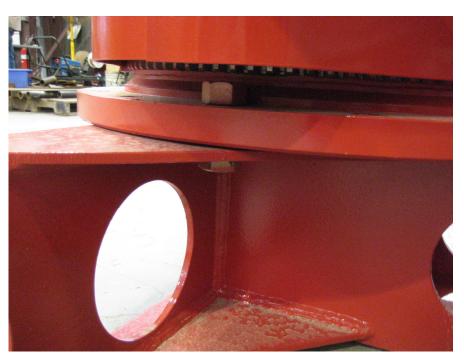
Figure 8

- Orient the wrench with the shipping skid and carefully lower the wrench onto the skid.
- 16. Fasten the base of the wrench to the shipping skid with the caps crew and nut (Figure 8). Torque to 250 ft-lbs.
