Model: All Serial #: All	Jun. 27, 2017
Product Bulletin # TDS-167

Alert

TD Frame Inspection

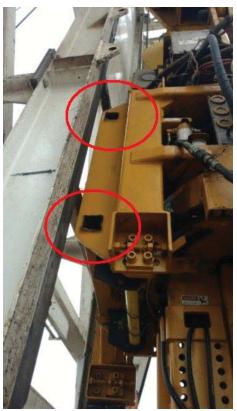
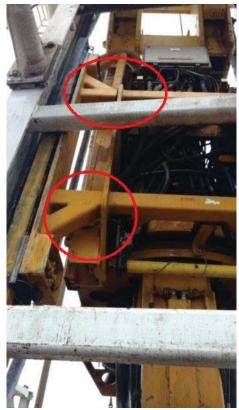
Figure 1: Frame Inspection Areas. Inspect Both Sides.

A crack that developed on a top drive guide runner assembly recently caused a near-miss dropped-object incident. The cause of this incident is still under investigation, but it is recommended that all rigs immediately inspect the top drive frame for signs of damage.

Inspect for signs of cracks, elongated parts, and missing components. Inspected areas should be cleaned of oil, mud, or other debris to ensure a thorough inspection. Perform a magnetic particle inspection of all welds on the guide runner assembly at the earliest possible date.

If abnormalities are discovered during inspection, contact RIGLINE 24/7™ Support for additional instructions.

The top drive guide runner assembly should be inspected regularly as outlined in Section 4 of the top drive manual, which is excerpted below:

Daily Inspections: The frame should be inspected daily for cracks, loose fits or connections, elongation of parts of other signs of wear, corrosion, overloading and proper operation.

Weekly Inspections: Visually inspect the frame for wear, deformation, cracks and corrosion.

- Visually inspect the welds for cracks or damage. Inspect for paint flaking or cracking, which may indicate potential failure. Examine for dents, bends, abrasion and corrosion.
- Visually check the top drive unit for loose bolts, nuts, broken wires on bolts or damaged safety wire. Retorque and rewire as required.
- Visually inspect electrical cables in junction boxes for wear, damage, or loose connections.
- Check for worn, cracked or distorted parts such as: pins, shafts, gears and guards.
